WF1104

Caple Free Standing wine cabinet

Computer Controlled Single Temperature and Synchronous Dual Temperature Wine Cellar

Service Manual

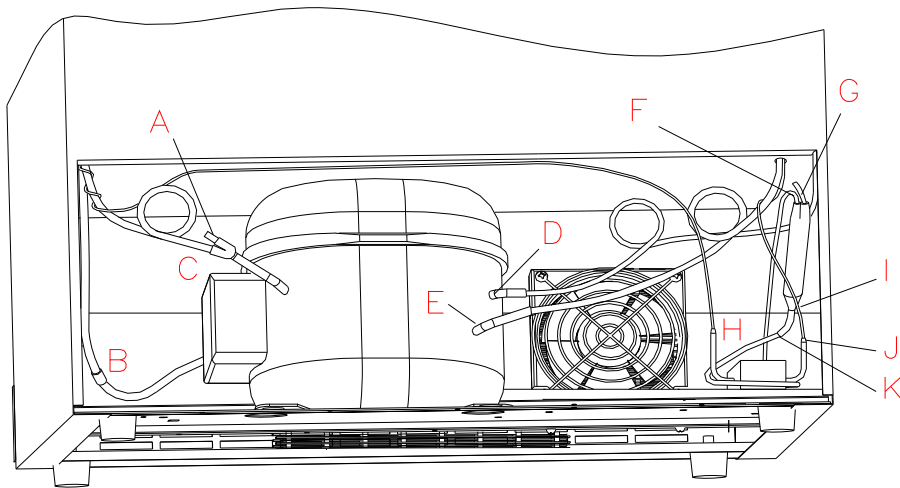
Fig. 5

The wine cellar with refrigerant valve (→6) (Fig.5)

A: Process pipe solder conjunction B: Dew clearance pipe solder conjunction

C: Lower compartment's circulating pipe solder conjunction

J: Refrigerant valve solder conjunction K: Upper compartment's capillary solder conjunction

1. This is the wine cellar with refrigerant valve's back solder conjunction distribution diagram

1>. Using the vacuum pump from a vacuum in the system, via the joint of the low-pressure pipe which on the process pipe of compressor (→5、 →6) (Fig.5, Fig.5.1 showing A), the high-pressure pipeline which on the process pipe of the drain filter (Fig.5, Fig.5.1 showing G). Apply the vacuum pump for approximately 20 minutes. Until the vacuum is lower than 100Pa. Then solder the drainpipe. Keep the vacuum running while soldering this joint

2>. Fill Cooling system with refrigerant via the process pipe (→5、 →6) (Fig.5, Fig.5.1 showing A). (The refrigerant is R134a. Regarding refrigerant quantity, please refer to the instruction at back label of wine cellar). Then solder the compressor process pipe after the system is charged with refrigerant.

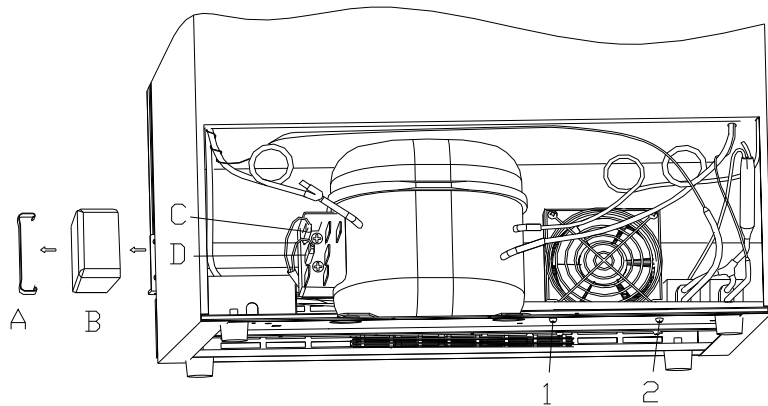
Fig. 7

Remove 2 screws (1 & 2), then replace the fan (→9) (Fig.7 & Fig.7.1)

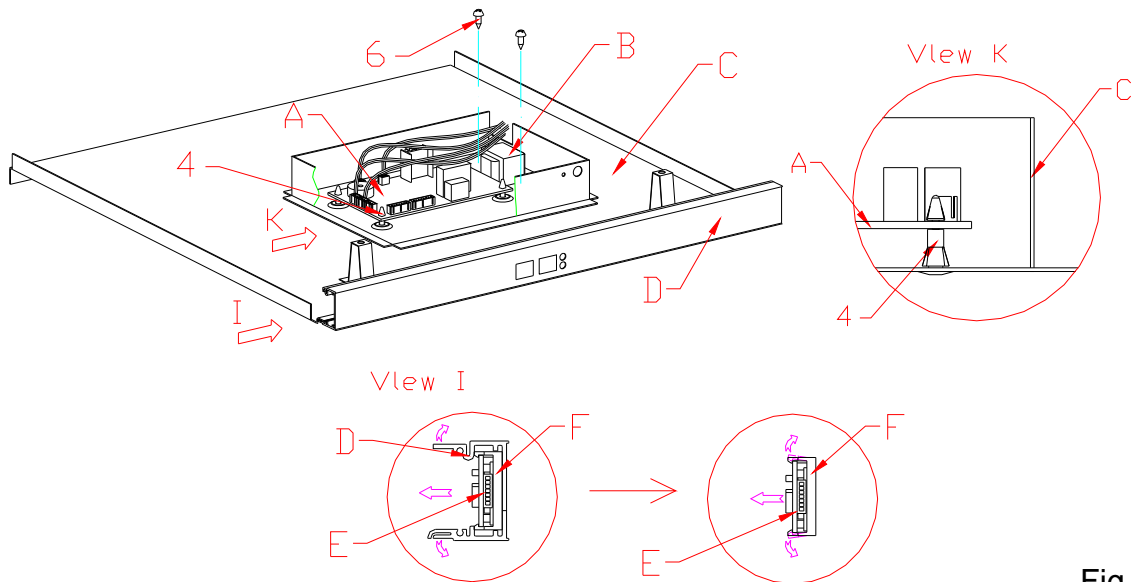
Fig. 10

4>. Unplug all the connectors, then press the head of each of the four plastic screws (4) one by one, then remove the control board and replace the control board see (Fig. 10) (Vlew K)

5>. Remove the two transformer fixing screws (6) and replace the transformer (Fig. 10)

Pull the four 4 display cover fasteners (D) as per arrowhead direction (Vlew I), and then remove the display board (E) and its two connectors from both sides. Replace the display board. See (Fig. 10) (Vlew I)

This fault caused by led displayer , just change it will be OK. (→13) (Fig.10 & Fig.10.1)

Please refer Page 13 (Fig.10 & Fig.10.1) for how to replace PCB board.
