WI3118WH

Caple 30cm 1 zone wine cabinet

Service Manual

(One temperature zone control wine cooler)

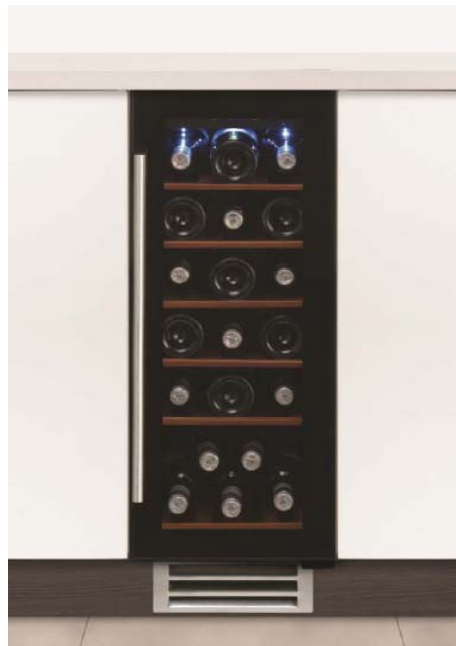
- 1
- 2
- 3
- 4
- 5
- 6
- 7
- 8
- 9
- 10
- 11
- 12
- 13
- 14
- 15
- 16
- 17
- 18
- 19
- 20
- 21
- 22
- 23
- 24
- 25
- 26
- 43

- 37
- 42
- 41
- 40
- 39
- 38
- 36
- 35
- 34
- 33
- 32
- 31
- 30
- 29
- 28
- 44
- 27

Item	Part Code	Description	Qty
1	DG11-45	Dry filter	1
2	DG2-14	Power cord	1
3	DG1-72	Compressor	1
4	DG13-199	Water tank	1
5	DG13-272-1	PCB board cover	1
6	DG6-7	Transformer	1
7	DG3-98-12	PCB board	1
8	DG26-133-1	Cabinet	1
9	DG13-268	Decorative nail	3
10	DG13-257	Evaporator fixing nip	2
11	DG14-190-SR	Top right hinge	1
12	DG12-44-2	Evaporator	1
13	DG13-158.1	Support pole	1
14	DG20-1	Wire nip	1
15	DG7-3.1-BH	Evaporator fan	1
16	DG13-158	Support pole	1
17	DG22-209	Air duct board	1
18	DG13-198	Sensor cover	1
19	DG8-8	Sensor	1
20	DG19-1	Fan cover	1
21	DG3-12-W	LED light	1
22	DG22-395	Electrical box	1
23	DG13-327	Display support	1
24	DG13-1.2	Water tank	1
25a	DG15-26.1	Wooden shelves A15A	1
25b	DG15-25	Stainless steel edged	5
26	DG23-242-3	Door	1
27	DG22-3057	Door axis	1
28	DG15-27	Wooden shelves C1	1
29	DG15-26	Wooden shelves A15A	4
30	DG20-317	Display panel	1
31	DG13-130-S	Button	4
32	DG13-383	Electrical box panel	1
33	DG13-353	Sealing piece	1

34	DG14-212-SR	Lower right hinge	1
35	DG22-40	Support bracket of front legs	1
36	DG13-6.11	Cabinet leg	4
37	DG22-39	Compressor bracket	1
38	DG12-3	Condenser	1
39	DG7-3.2-BH	Condenser fan	1
40	DG19-3	Fan cover	1

Item	Part Code	Description	Qty
41	DG14-33	Fan fixing piece	2
42	DG12-58	Air-circulating pipe	1
43	M184-041	Gasket	1
44	DG22-3027	Handle	1
A	DG14-190-SL	Top left hinge	1
B	DG14-212-BL	Lower left hinge	1
C	DG22-3022	Bottom grill	1
D	DG22-3055-1	Bottom grill	1
E	DG22-3145	Bottom grill bracket	2

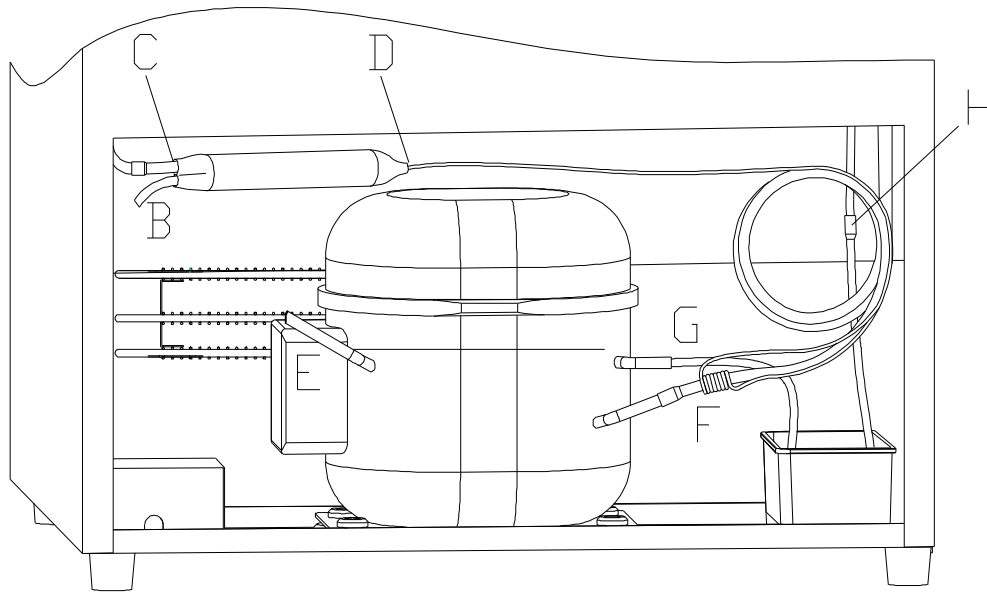
Fig.9.1

○ Diagram showing the rear side solder joints. There are two different condensers: built-in(Fig.8) and outboard condenser).See (Fig.9 & Fig.9.1)

- B: Dry filter process pipe soldered joint C: Dry filter soldered joint D: Capillary soldered joint
 E: Process pipe soldered joint F: Suction pipe soldered joint G: Discharge pipe soldered joint
 H: Condenser process pipe soldered joint I: Anti-Dew pipe soldered joint

Outboard condenser

B. Make sure the capillary is working normally, when the drainpipe is conncted again, and infuse 0.8-1MP nitrogen then test the leakage if the cooling system of the soldering point with the soap water. Check from the the soldering point around the compressor(Fig.8 & Fig.9、Fig.9.1), and if everything is ok, remove the air-duct board and chech the soldering point around evaporator(Fig.6 & Fig.7). please see the remove method and the procedure as below. (Fig.1, Fig.2 ,Fig.3, Fig.4 & Fig.5)

- 1>.Heat the soldered joint of the capillary (A of Fig.8 and Fig.9, Fig.9.1), then remove the capillary from the evaporator and smooth the end with an eraser (Caution: Do not allow any particles into capillary unit)
- 2>.Replace the capillary into the evaporator, then solder it back into the correct position (not exceeding 15mm in the evaporator) and pack the joint with anti vibration compound
- 3>. Recharge with refrigerant. See (Page7)

- 1>. De-solder the capillary and re-solder in the correct position avoiding contact with the inside of the evaporator, (The depth should be within 15mm), then recharge the unit with refrigerant see (→7)
- 2>. If the capillary touches the inside of the cabinet or air duct board, you should adjust position of capillary and pack it with anti-vibration compound. (Fig.8 & Fig.9、 Fig.9.1)

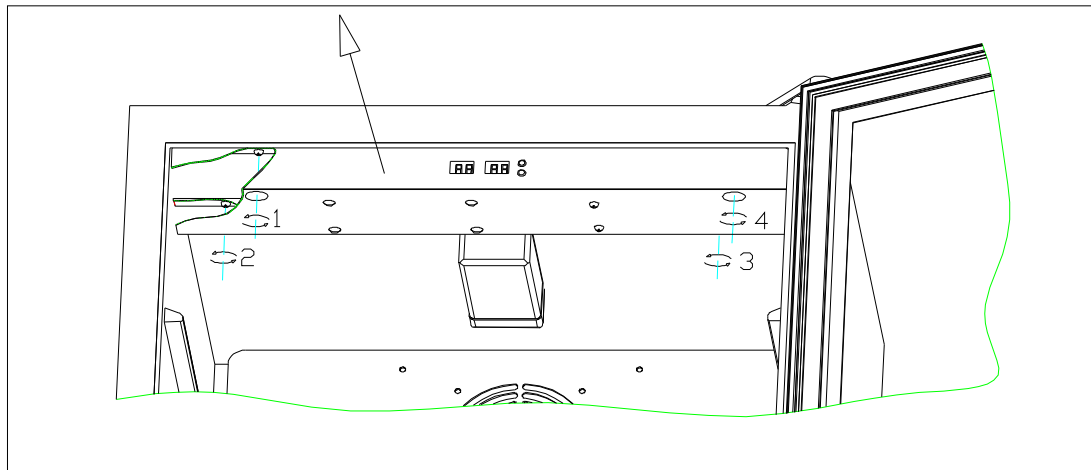
Fig.18

- 1 >. Remove the shelves; see (Fig.1, Fig.2 ,Fig.3, Fig.4)
- 2 >. Remove the two screws at back of electrical box (2,3), then half-remove the two front screws (1,4), then remove the electrical box; see (Fig.18)

1 >. Normally the LED temperature display should the ambient temperature shortly after the unit is plugged in, if not, disassemble the electrical box see (Fig.18 & Fig.19), check if the sensor plug marked “XI” connected properly, if this connection is made correctly and the fault persists replace this sensor,

- 2 >. If the LED displays” E1” it indicates the inner sensor should be replaced see (Fig.18 & Fig.19)
- 3 >. If the LED displays” E2” it indicates the inner sensor should be replaced see (Fig.18& Fig.19)
- 4 >. For some older models with old computerized control panels,If the LED displays 37°C, 99F or, infinity, replaces the sensor. See(Fig.18& Fig.19)

Replace the electrical display board fault; see (Fig.18& Fig.19)

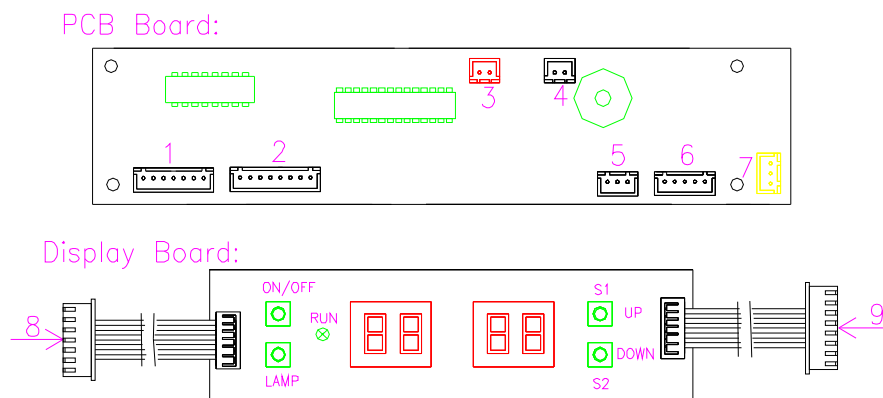
Fig.20

Diagram of the main PCB(Fig.20).

| 1. To display PCB(connect to 8) | 2. To display PCB(connect to 9) |
| 3.To evaporator sensor (Red) | 4.To inner sensor(White) |
| 5.To LED light (White) | 6.To power PCB (White) |
| 7. To outer fan (Yellow) | |
