WI6115

Caple 60cm Wine Cabinet

Service Manual

(One temperature zone control wine cooler)

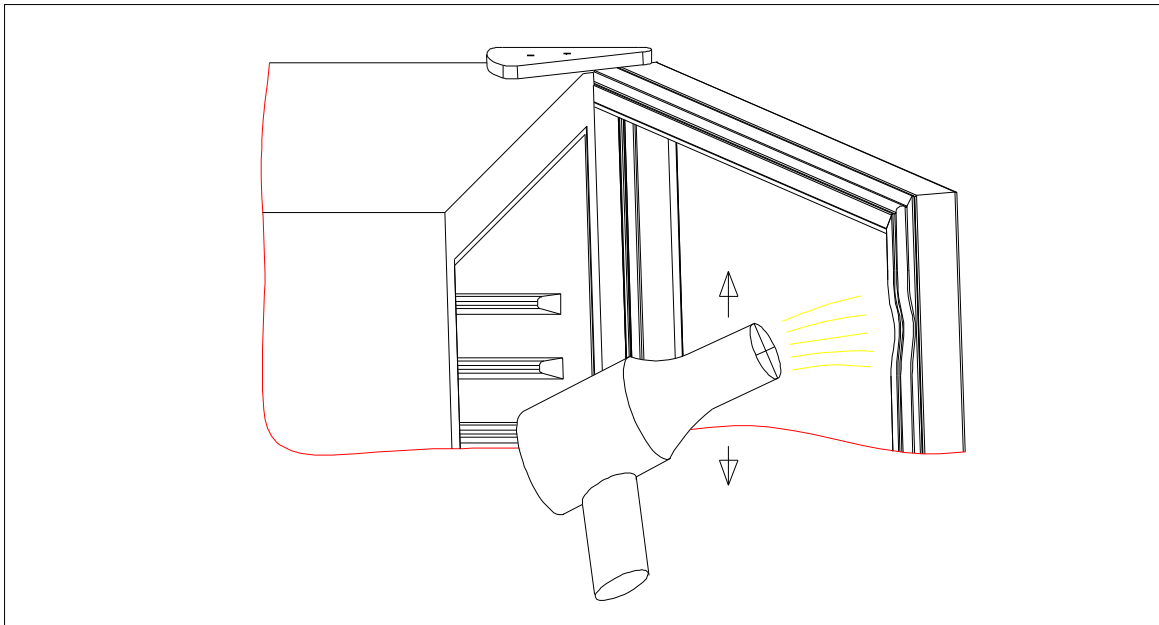
Fig.12

1>. Ensure door is sealed against the frame, if there is slight distortion of the seal, heat the effected area gently with a hair dryer genrly see (fig 12) with smooth strokes of the hair dryer, then when still warm pull the effected area back into its original position, this process may have to be repeated until the seal is completely back to its original condition.

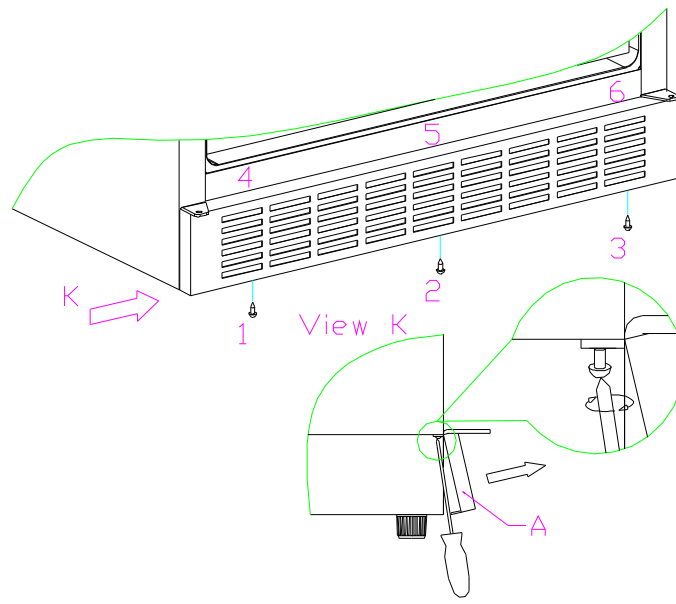
Fig.25

Remove the screw(1,2,3), pull the decorative frame according to the arrowhead that view K show, then remove the screw(4,5,6) from the gap between decorative frame and cabinet, remove the decorative frame. (Fig.25)
