WI6225

Caple 60cm 2 Door Wine Cabinet

Computer Controlled Synchronous Dual Temperature
Wine cooler JG2D1

service manual

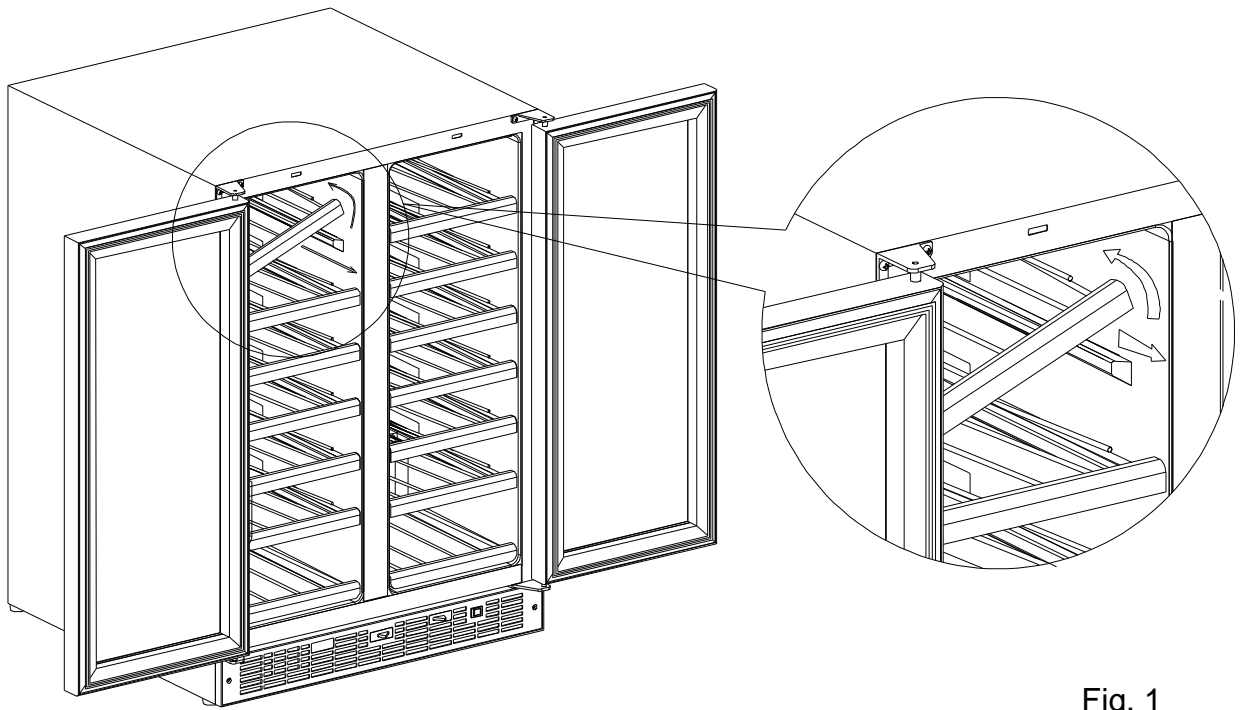
Fig. 1

1>. Pull the shelves to the bottom, circumvolve any side of the right and left, and let the setter of the shelve go out of the channel, and then draw out the shelves. (Fig.1)

1>. Remove the shelves. (→3) (Fig.1)

A. Remove the shelves. (→3) (Fig.1)

1 >. Remove the shelves ;(Fig.1)

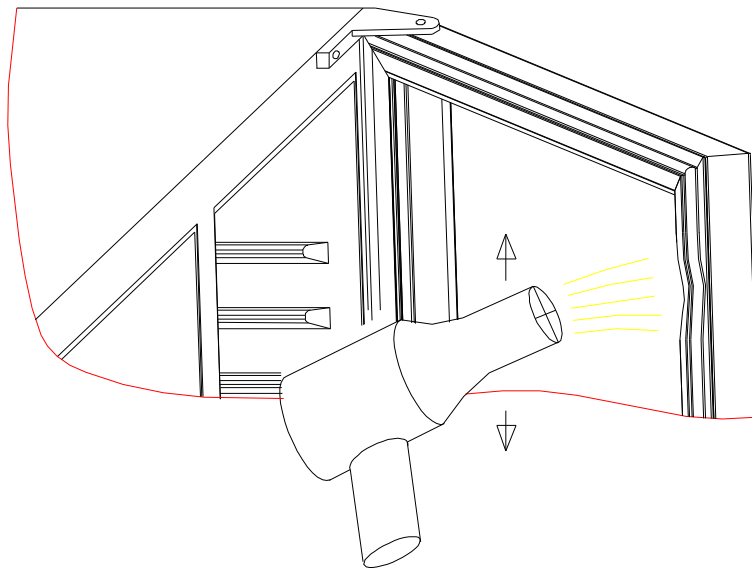
Fig. 7

Aiming at the distortion of the gasket with the heat dryer, and move up and down or right and left until it expand to the normal state. When it is cool, check it with the door closed, if there is any distortion, dry it again until it fix for the door. (Fig.7)

1>. Replace the door gasket or close the door well. If the door gasket is slightly not air-proof, it can be repaired by the heat dryer.

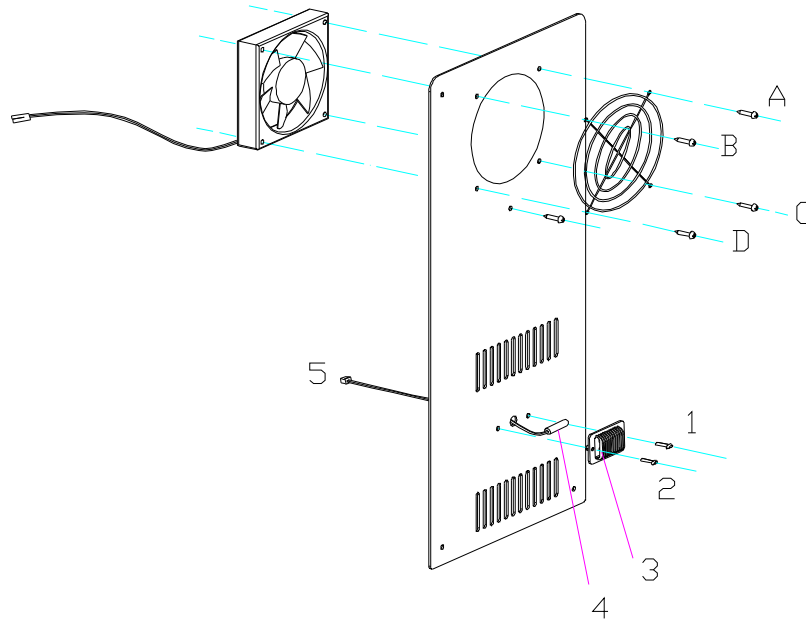
Fig.8

C. Push and then pull out the two plastic nails(1,2),the sensor cover(3) come loose, disconnect the connector(5) of the sensor, and replace it(4). (Fig.8)

2 >. The LED display shows E7, and it is the left zone's sensor open circuit fault, check the connection wire and the main board whether open circuit, if not, replace the sensor with the same module. See(Fig.8.)

3 >. The LED display shows E8, and it is the left zone's sensor short circuit fault, check the connection wire and the main board whether short circuit, if not, replace the sensor with the same module. See(Fig.8.)

4 >. The LED display shows E1, and it is the right zone's sensor open circuit fault, check the connection wire and the main board whether open circuit, if not, replace the sensor with the same module. See(Fig.8.)

5 >. The LED display shows E2, and it is the right zone's sensor short circuit fault, check the connection wire and the main board whether short circuit, if not, replace the sensor with the same module. See(Fig.8.)

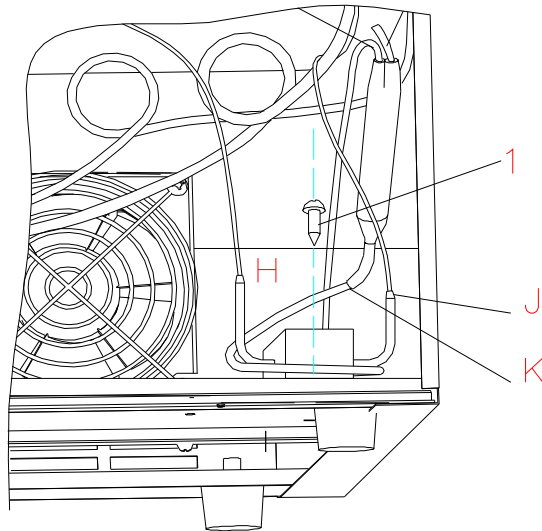
Fig. 9

A. Use welding facility to heat the 3 welding point H, K, J, and then take off the refrigerant valve. (Fig. 9)

B. Use the cross screwdriver to wrest the refrigerant welding screw 1 (totally 2pcs, another isn't show in the picture.) ; (Fig.9)

a. Check the valve by hearing the sound. turn off the wine cooler and exchange the connectors of the valve then power on, listen carefully you can hear the snip-snap sound from valve, otherwise the valve is power off or broken or the PCB fault. Confirming the PCB is normal, replace the valve. (→8) (Fig.9)

b. The refrigerator valve damage and can not be switch, cause not cooling, replace with the new one.(Fig.9)

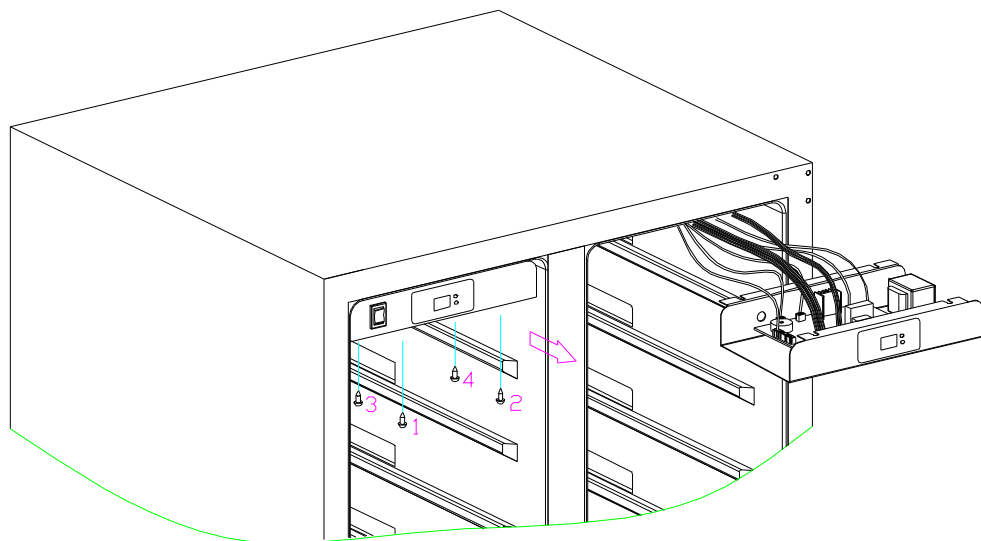
Fig. 10

2 >. Screw the two bolts out from the electrical box (3, 4), half loose the two bolts(1, 2) which in the front of the box, pull the electrical box out (Fig.10)

3 >. If the above a~e point is line in the situation, and every components of the machine is normal; if there is any different, and firstly check the abnormal components and their connection wire. If the connection is tight, replace the components. If the replacement fail, it can be judged as control PCB's fault, please replace it with the same module. (Fig.10 & Fig.11)

1 >. After turning on the power, if the LED display shows the temperature is similar with the ambient temperature, it is normal, if abnormal, please remove the electrical box, (Fig.10 & Fig.11) (→9), check the sensor insert "X7" or "X8" whether reliable. If the insert is reliable, it is the sensor's fault, replace the sensor with the same module.

This fault caused by led displayer broken, just change it will be OK. (Fig.10 & Fig.11)

- 1>. Follow the removing methods to remove the PCB board; (Fig.10 & Fig.11)
- 2>. Then you will see the LED light is divided in to 3 parts, then pull out the line (1)follow the arrowhead's heading; (Fig.15)
- 3>. Pull out fasteners of the LED installed board (B) follow the View K point 1, at the time peak up the LED light board(A), then change the LED light board.

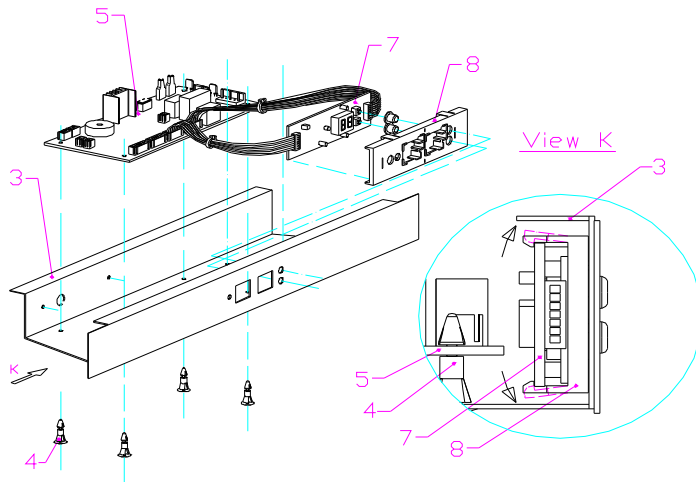
Fig. 11

3 >. The explode drawing of replaced electrical box is below; (Fig.11)

- 4 >. Unplug all the connectors, then press the head of each of the four plastic studs (4) one by one, and move up-ward the control board, remove the control board, and replace it with the new module. See. (Fig. 11)
- 5 >. Replace the LED display board. Unplug the four 4 display cover fasteners on display board supporter (8) as per arrowhead direction, and then remove the display board, and its two connectors from both sides, Replace the display board. See (Fig. 11 & Fig. 12)

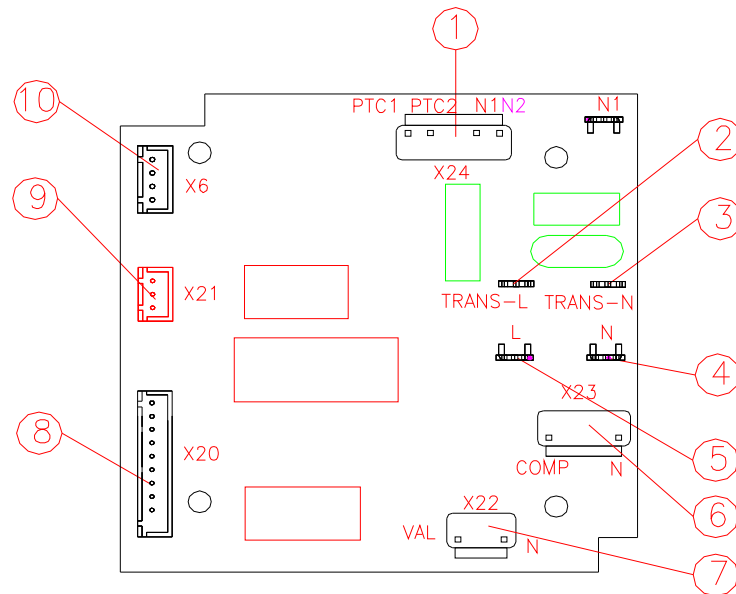
Fig. 13

○ The name and explanation of the power PCB (Fig. 13)

1. To PTC heater (white)
2. To transformer primary (L)
3. To transformer primary(N)
4. To the main power N
5. To the main power L
6. To the compressor
7. To the valve
8. To the main PCB(white)
9. To the condenser fan(Red)
10. To the transformer secondary

2>. Pull off the of the fan connector on the power PCB. (Fig.13)

- 1 >. Remove the 2 screws (1); (Fig.14)
- 2 >. Remove the electrical box; (Fig.14)
- 3>. Unplug all the connectors, then press the head of each of the four plastic screws (4), move up-ward the power PCB (A), then replace a new one. (Fig.14) (View K)
- 4>. Plug all the connectors; (Fig.13)
- 5>. Remove the 2 screws (B) and transformer, then replace a new transformer.(Fig.14)
