# WI6230

Caple 60cm wine cabinet

Computer Controlled Synchronous Dual Temperature  
Wine cooler JG2D1

**service manual**

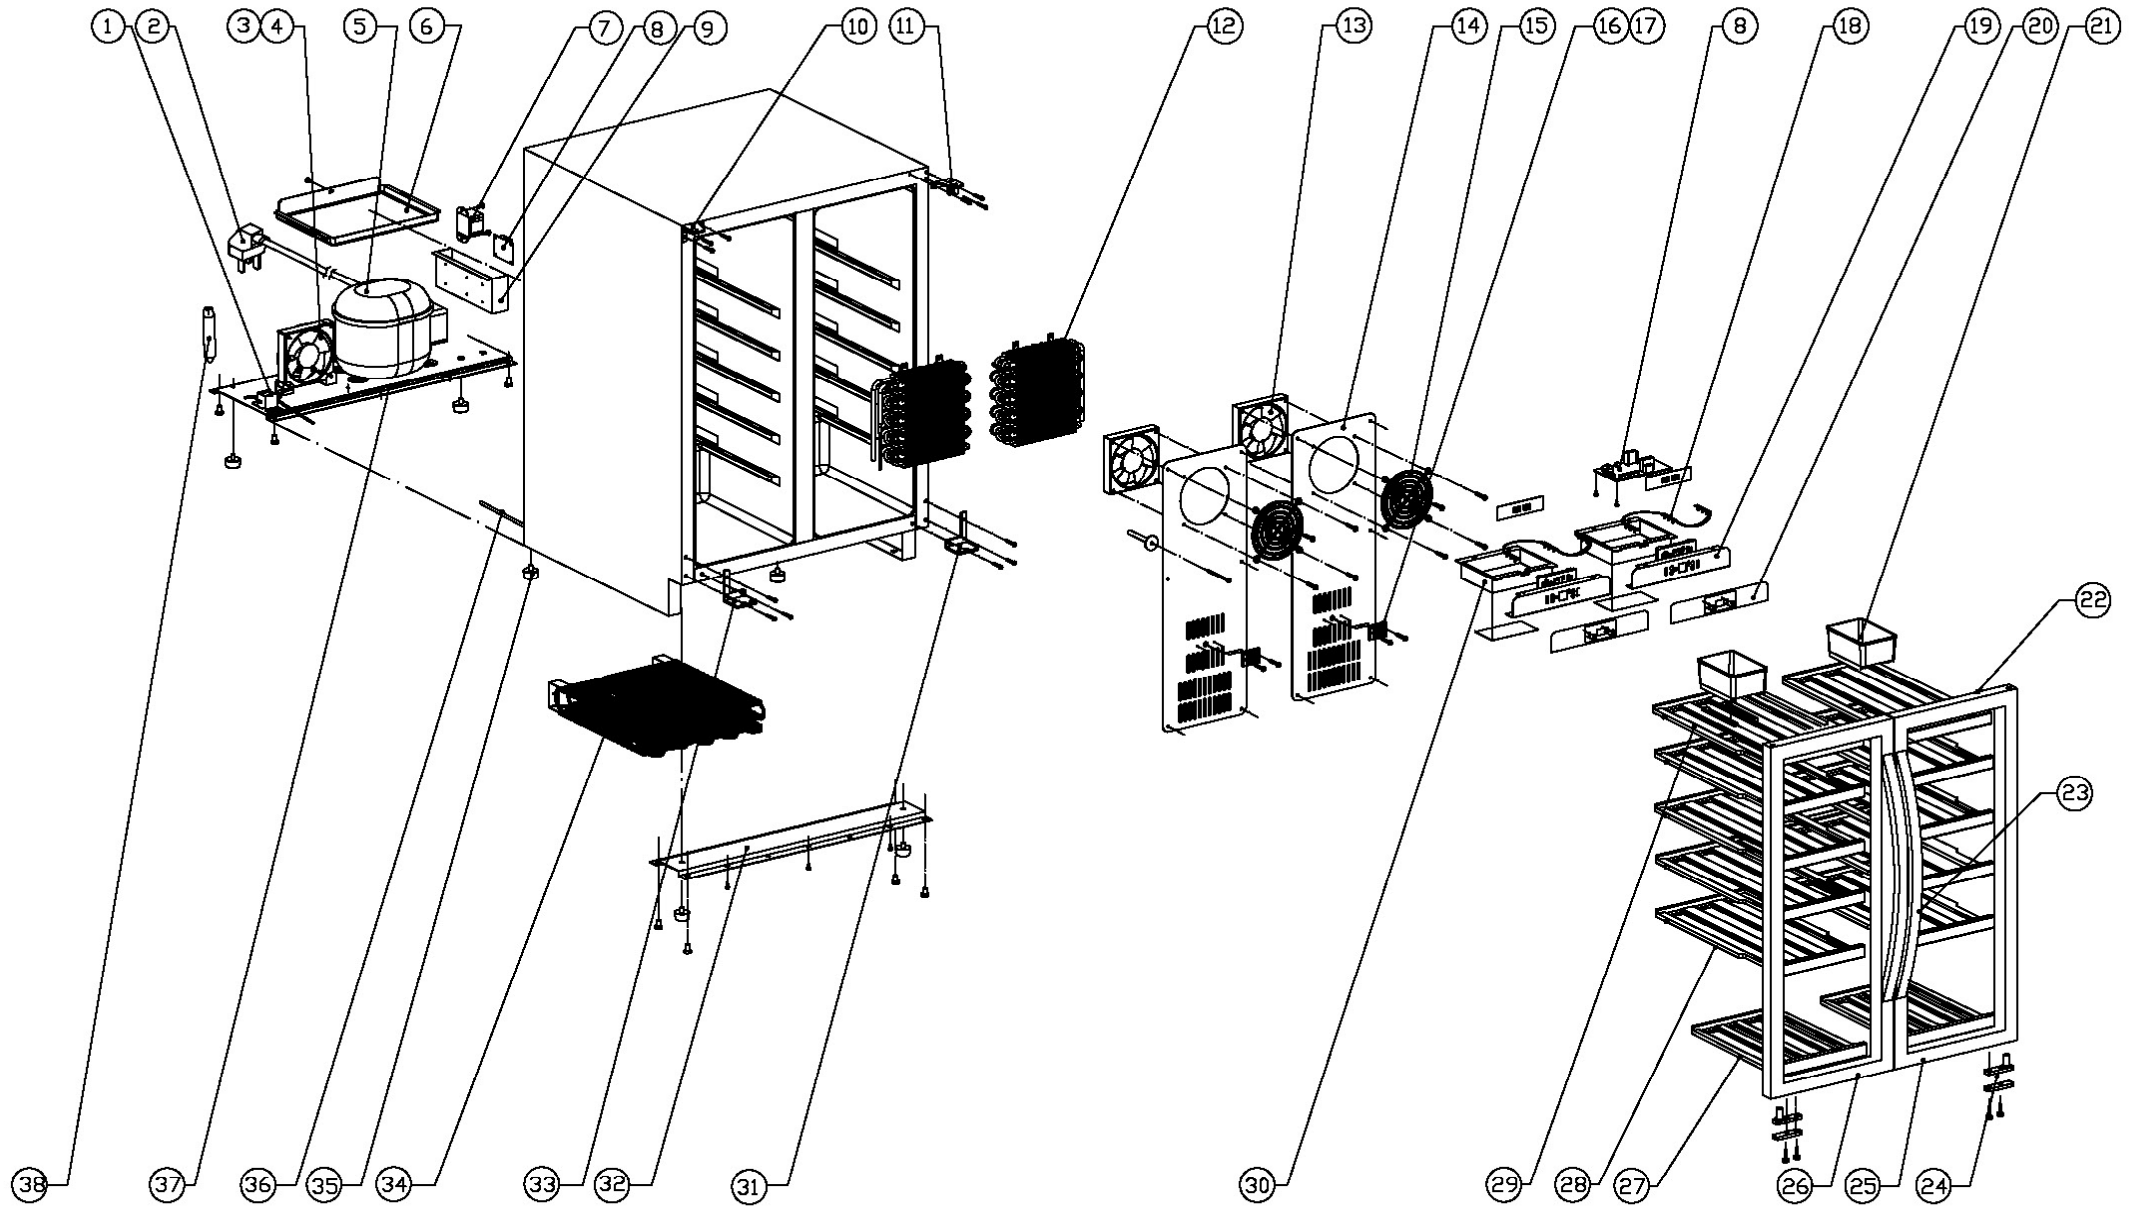
## WI6230 - Caple wine cabinet

| Item | Part Code | Description | Qty |

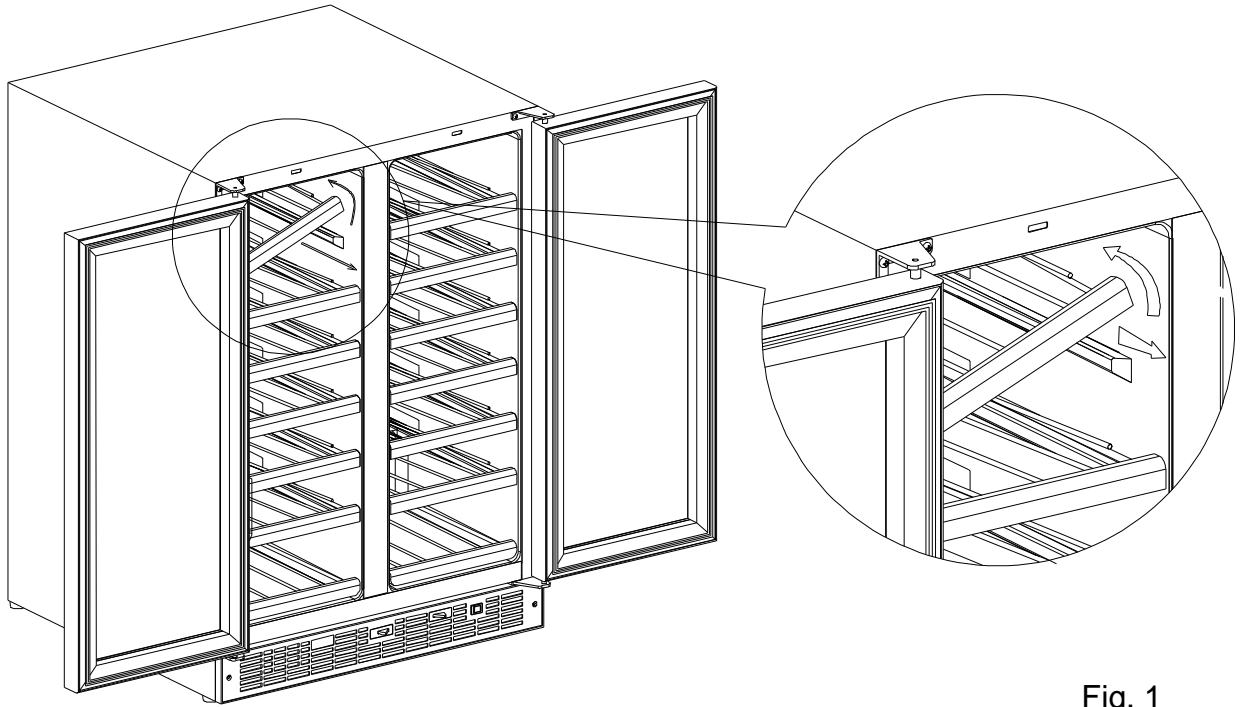
Fig. 1

1>. Pull the shelves to the bottom, circumvolve any side of the right and left, and let the setter of the shelve go out of the channel, and then draw out the shelves. (Fig.1)

1>. Remove the shelves. (→3) (Fig.1)

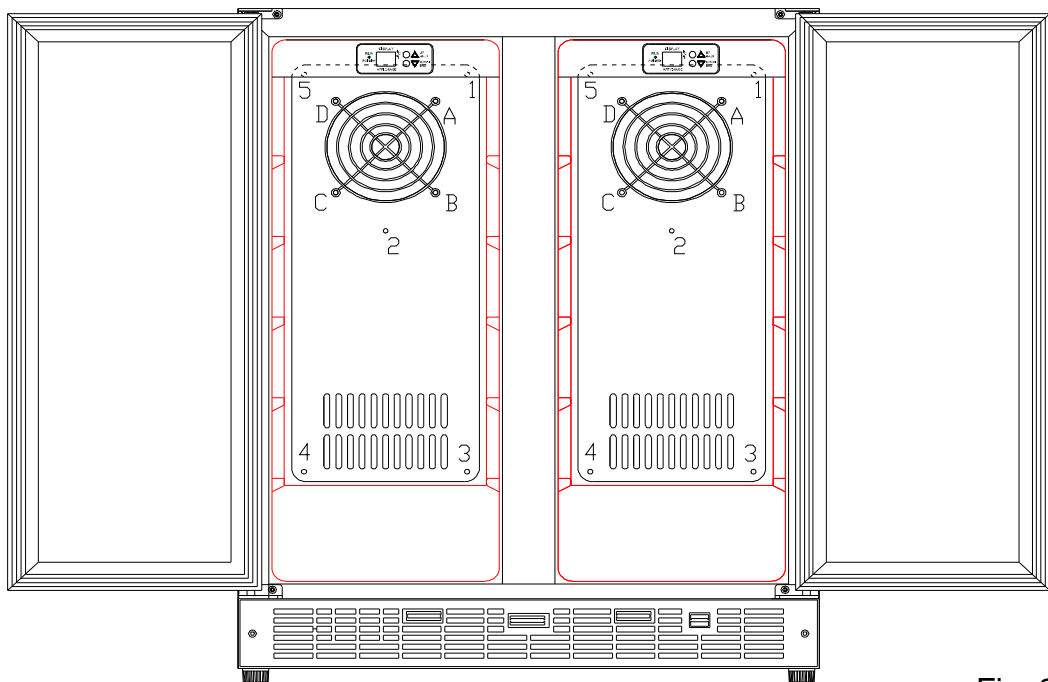
Fig. 2

2>. Use a Set of cross-screwdrivers to remove the air-duct board screws (Note: 1~5 are the air-duct board screws. A~D are the fan screws, need not to remove), and remove the air-duct board. Be attention to unplug the connection wire when removing the air-duct board. You can move slowly aside until you can see the fans wire, and unplug the fan connector, and then take out the whole air-duct board. ;(Fig.2)

- b .Make sure the capillary is in good condition, join the discharge pipe, infill 0.8-1Mpa nitrogen via the assistant pipe, check all the joints with soap water if any leak from any of them. Check the back side joints around the compressor first (Fig.4),if it without any leak check front side joints(Fig.3 ).Before checking front side joints you need to remove the airduct board(Fig.1 & Fig.2).

2> . Remove the air duct board. See (→3) (Fig.2)

3>. Remove screws (A, B, C, D), then replace the evaporator fan See (Fig.2 & Fig.5)

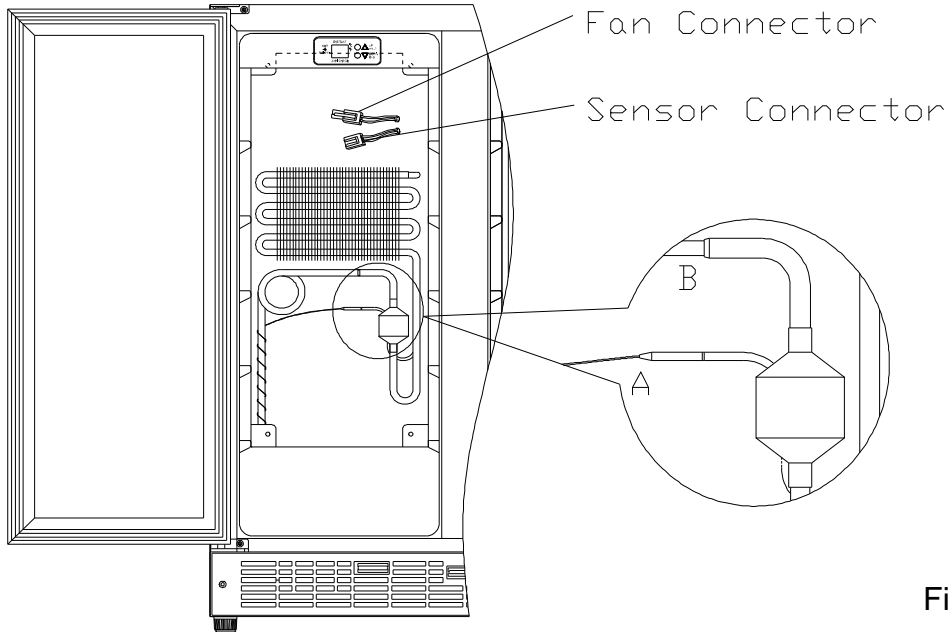
Fig. 3

3>. The picture after removing the airduct board. (Fig.3 )

○ Diagram showing the front side soldered joints(Fig.3 )

A: Capillary soldered joint

B: Evaporator soldered joint

- 1>. Heat the soldered joint of the capillary (Fig.3 showing A point), then remove the capillary from the evaporator and smooth the end with an eraser. (Caution: do not allow any particles into capillary unit).
- 2>. Replace the capillary into the evaporator, then solder it back into the correct position (not exceeding 15mm in the evaporator) and pack the joint with anti vibration compound.
- 3>. Vacuumize and recharge with refrigerant. See (→2)

- 1>. If the capillary is inserted too deep, heat it with the solder, solder it again(Please noted, the deep inserted is not bigger than 15mm), and vacuumize it and add the refrigerant. (→2)
- 2>. If the capillary touch the inner cabinet or the air duct panel, adjust the position of the capillary and add the incabloc plastic. (Fig.3)

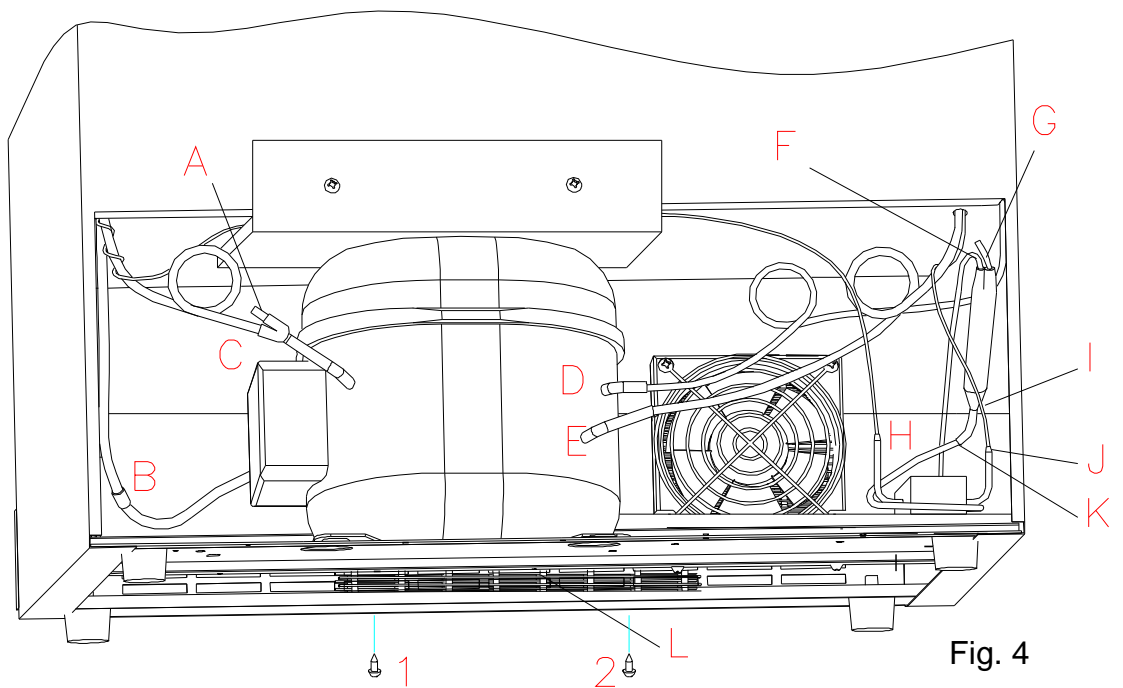
Fig. 4

○ Diagram showing the back side soldered joints(Fig.4 )

A: Compressor assistant pipe soldered jointed

C: Right zone suction pipe soldered joint

E: Left zone suction pipe soldered joint

G: Filter soldered joint

Connector pipe joint

K: Left zone capillary soldered joint

B: Anti-dew pipe soldered joint

D: Discharge pipe soldered joint

F: Condenser soldered joint

H: Right zone capillary soldered joint I:

J: Valve soldered joint

L: Condenser soldered joint

If neither zones can not refrigerate, check the current of the compressor with a clamp Ampere meter, and the current should be within 0.8 to 2 A. If the current not in this range, turn off and cut off the exhaust(Fig.4 ,see point D) and assistant pipe(Fig.4 ,see point A), electrified the wine cooler and check the current again, check the discharge pipe of the compressor at the same time, if it has an clear air pressure, if the electricity is still too high or has not air pressure, it shows that the compressor is failed by itself, and you need to replace the compressor. (Noted: To avoid the compressor suck the moist,run the compressor not longer than 15 minutes after the assistant pipe and discharge pipe cut off.)

1>. Using the vacuum pump form a vacuum in the system, via the joint of the low-pressure pipe (Fig.4,see point A), the high-pressure pipeline is on the process pipe of the filter. Apply the vacuum pump for approximately 20 minutes. Until the vacuum is lower than 100Pa. Then solder the process pipe of the filter Keep the the system vacuum.

2>. Fill Cooling system with refrigerant via the process pipe (Fig.4,see point A). The refrigerant and quantity Please refer to the instruction at back label of wine cellar. Then solder the compressor process pipe after the system is charged with refrigerant.

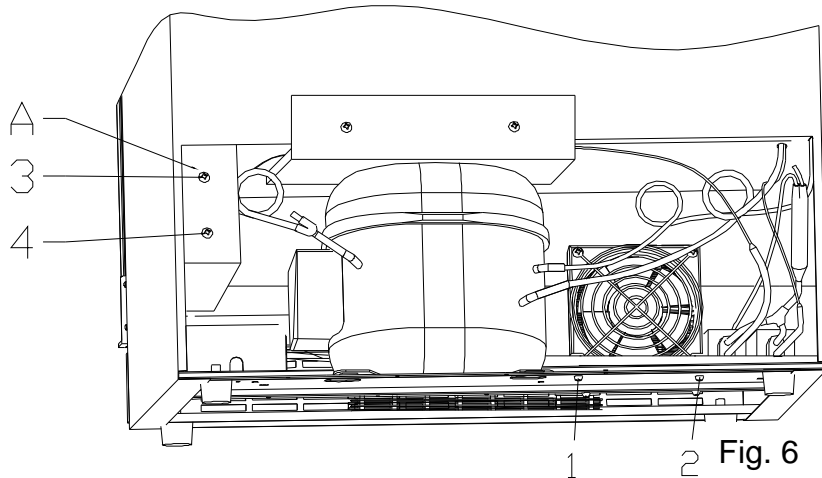
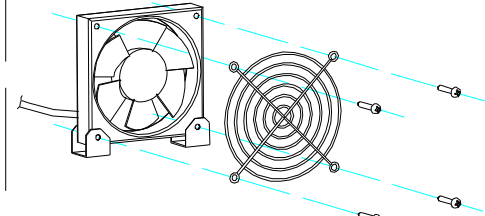
Fig. 6

1>. Remove the screws(3,4) ,take apart the electrical box (A) ;(Fig.6)

3>. Lean back the cabinet 45°, or put it on the workbench, and use a Set of cross-screwdriver to wrest off the two screws(1,2) of compressor bottom penal, and remove the condenser fan to replace with a new one. (Fig.6 & Fig.6.1)

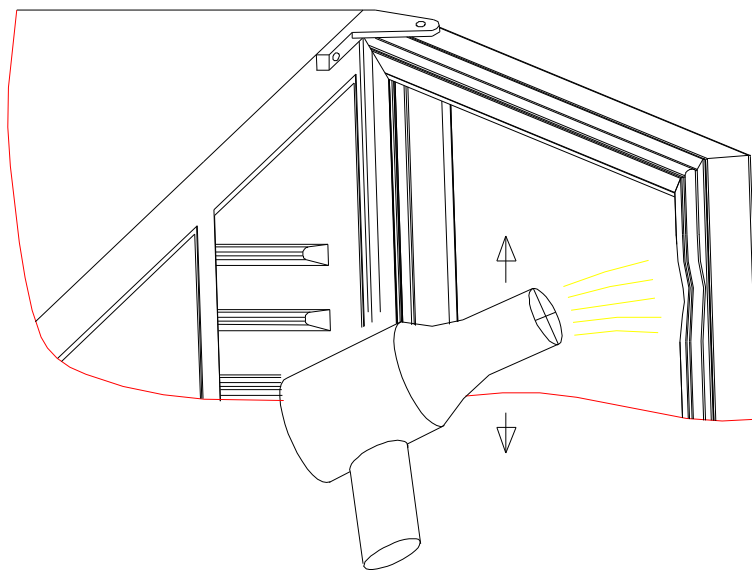
Fig. 7

Aiming at the distortion of the gasket with the heat dryer, and move up and down or right and left until it expand to the normal state. When it is cool, check it with the door closed, if there is any distortion, dry it again until it fix for the door. (Fig.7)

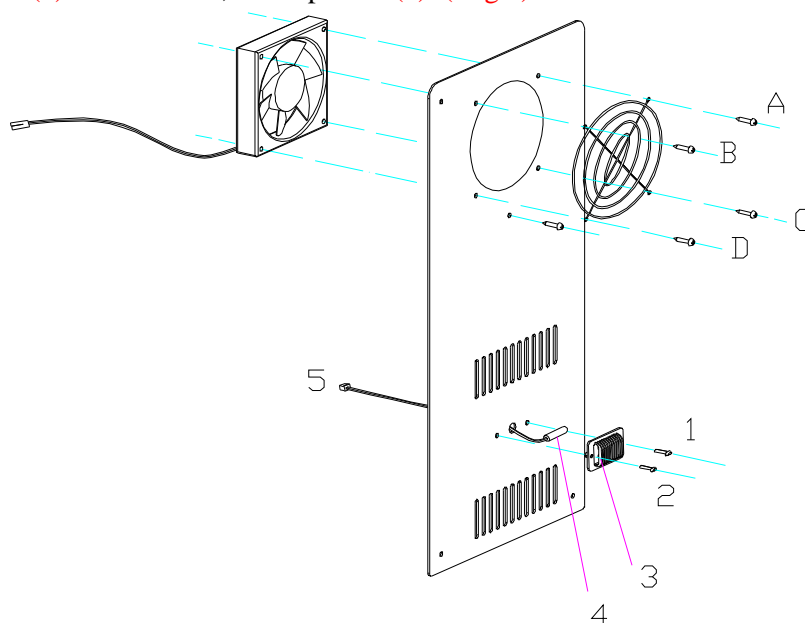
Fig.8

- A. Remove the shelves. (→3) (Fig.1)
- B. Remove the air duct board. See (→4) (Fig.2)
- C. Push and then pull out the two plastic nails(1,2),the sensor cover(3) come loose, disconnect the connector(5) of the sensor, and replace it(4). ( Fig.8)

2 >. The LED display shows E7, and it is the left zone's sensor open circuit fault, check the connection wire and the main board whether open circuit, if not, replace the sensor with the same module. See(Fig.8.)

3 >. The LED display shows E8, and it is the left zone's sensor short circuit fault, check the connection wire and the main board whether short circuit, if not, replace the sensor with the same module. See(Fig.8.)

4 >. The LED display shows E1, and it is the right zone's sensor open circuit fault, check the connection wire and the main board whether open circuit, if not, replace the sensor with the same module. See(Fig.8.)

5 >. The LED display shows E2, and it is the right zone's sensor short circuit fault, check the connection wire and the main board whether short circuit, if not, replace the sensor with the same module. See(Fig.8.)

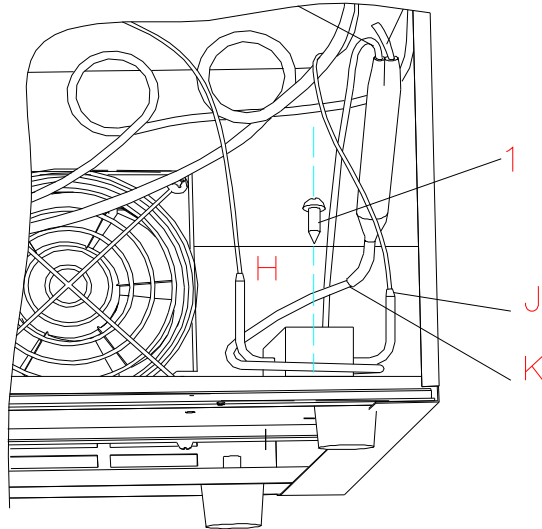
Fig. 9

- 3 >. How to replace the refrigerant valve:
  - A. Use welding facility to heat the 3 welding point H, K, J, and then take off the refrigerant valve. (Fig. 9)

- B. Use the cross screwdriver to wrest the refrigerant welding screw 1 (totally 2pcs, another isn't show in the picture.) ; (Fig.9)
  - C. Replace with the new refrigerant valve, and vacuumize it, and refill refrigerant, complete the replacement.

a. Check the valve by hearing the sound. turn off the wine cooler and exchange the connectors of the valve then power on, listen carefully you can hear the snip-snap sound from valve, otherwise the valve is power off or broken or the PCB fault. Confirming the PCB is normal, replace the valve. (→8) (Fig.9)

b. The refrigerator valve damage and can not be switch, cause not cooling, replace with the new one.(Fig.9)

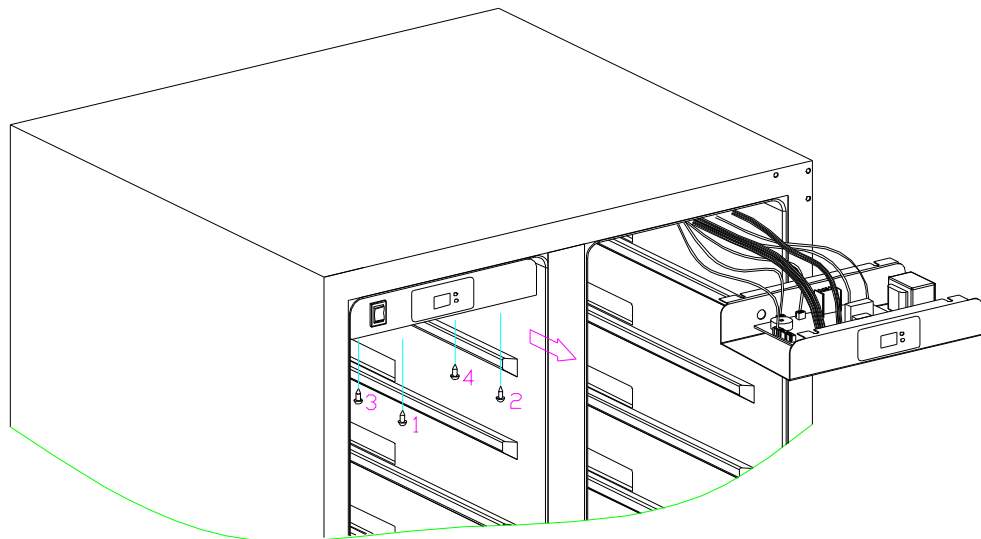
Fig. 10

2 >. Screw the two bolts out from the electrical box (3, 4), half loose the two bolts(1, 2) which in the front of the box, pull the electrical box out ( Fig.10 )

3 >. If the above a~e point is line in the situation, and every components of the machine is normal; if there is any different, and firstly check the abnormal components and their connection wire. If the connection is tight, replace the components. If the replacement fail, it can be judged as control PCB's fault, please replace it with the same module. (Fig.10 & Fig.11)

1 >. After turning on the power, if the LED display shows the temperature is similar with the ambient temperature, it is normal, if abnormal, please remove the electrical box, (Fig.10 & Fig.11) (→9), check the sensor insert "X7" or "X8" whether reliable. If the insert is reliable, it is the sensor's fault, replace the sensor with the same module.

This fault caused by led displayer broken, just change it will be OK. (Fig.10 & Fig.11)

- 1>. Follow the removing methods to remove the PCB board; (Fig.10 & Fig.11)
- 2>. Then you will see the LED light is divided in to 3 parts, then pull out the line (1)follow the arrowhead's heading; (Fig.15)
- 3>. Pull out fasteners of the LED installed board (B) follow the View K point 1, at the time peak up the LED light board(A), then change the LED light board.

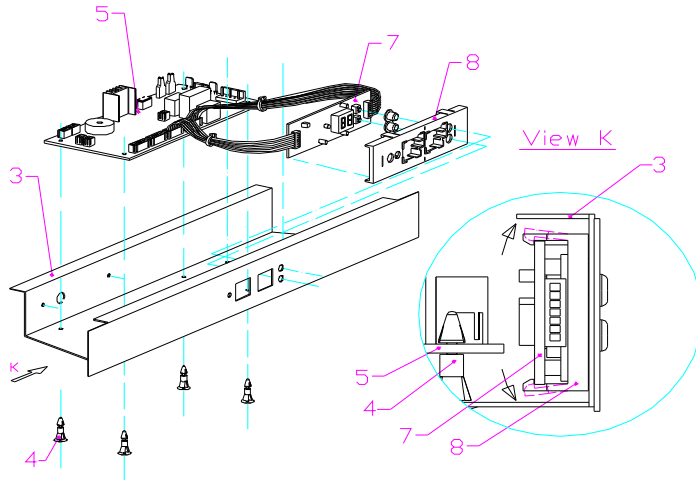
3 >. The explode drawing of replaced electrical box is below; ( Fig.11)

- 4 >. Unplug all the connectors, then press the head of each of the four plastic studs (4) one by one, and move up-ward the control board, remove the control board, and replace it with the new module. See. ( Fig. 11)
- 5 >. Replace the LED display board. Unplug the four 4 display cover fasteners on display board supporter (8) as per arrowhead direction, and then remove the display board, and its two connectors from both sides, Replace the display board. See ( Fig. 11 & Fig. 12)

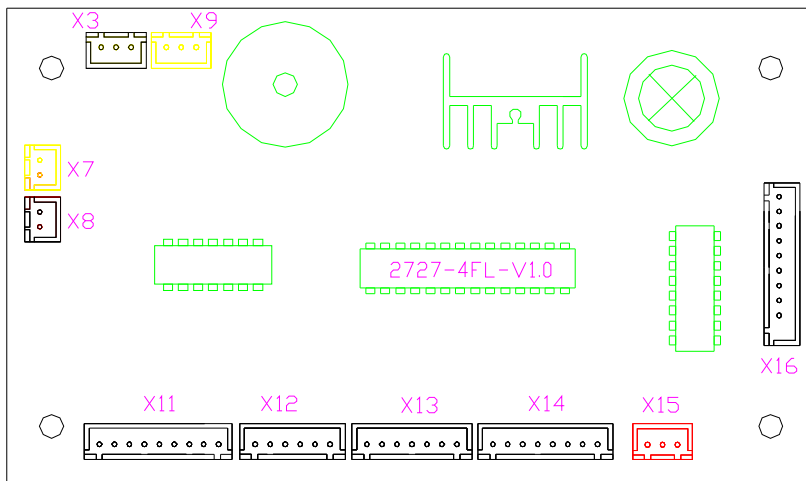
Fig. 12

○ The name and explanation of the main PCB board connectors(Fig. 12)

- X7: To right zone sensor(yellow)
- X8: To left zone sensor(white)
- X9: To right zone fan(yellow)
- X3: To left zone fan(white)
- X11、 X12: To left zone display PCB
- X13、 X14: To right zone display PCB
- X15: To LED light (red)
- X16: To power PCB

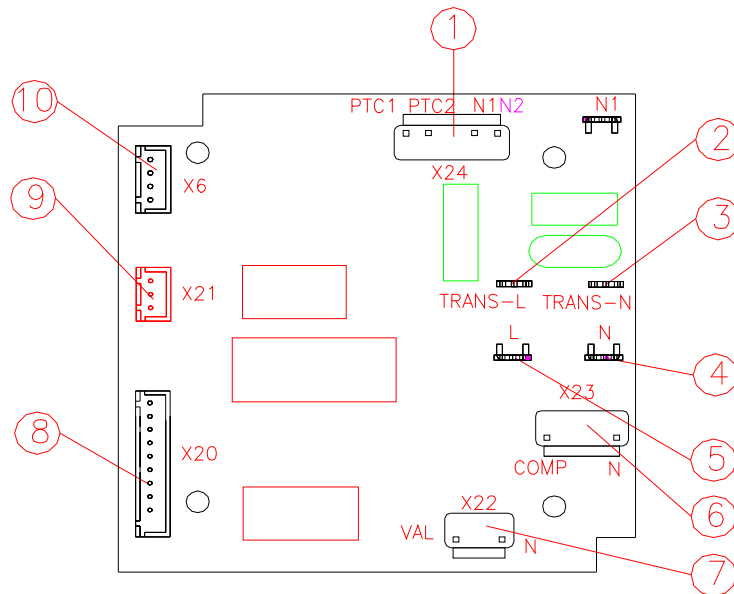
Fig. 13

○ The name and explanation of the power PCB ( Fig. 13)

1. To PTC heater (white)
2. To transformer primary (L)
3. To transformer primary(N)
4. To the main power N
5. To the main power L
6. To the compressor
7. To the valve
8. To the main PCB(white)
9. To the condenser fan(Red)
10. To the transformer secondary

2>. Pull off the of the fan connector on the power PCB. (Fig.13)

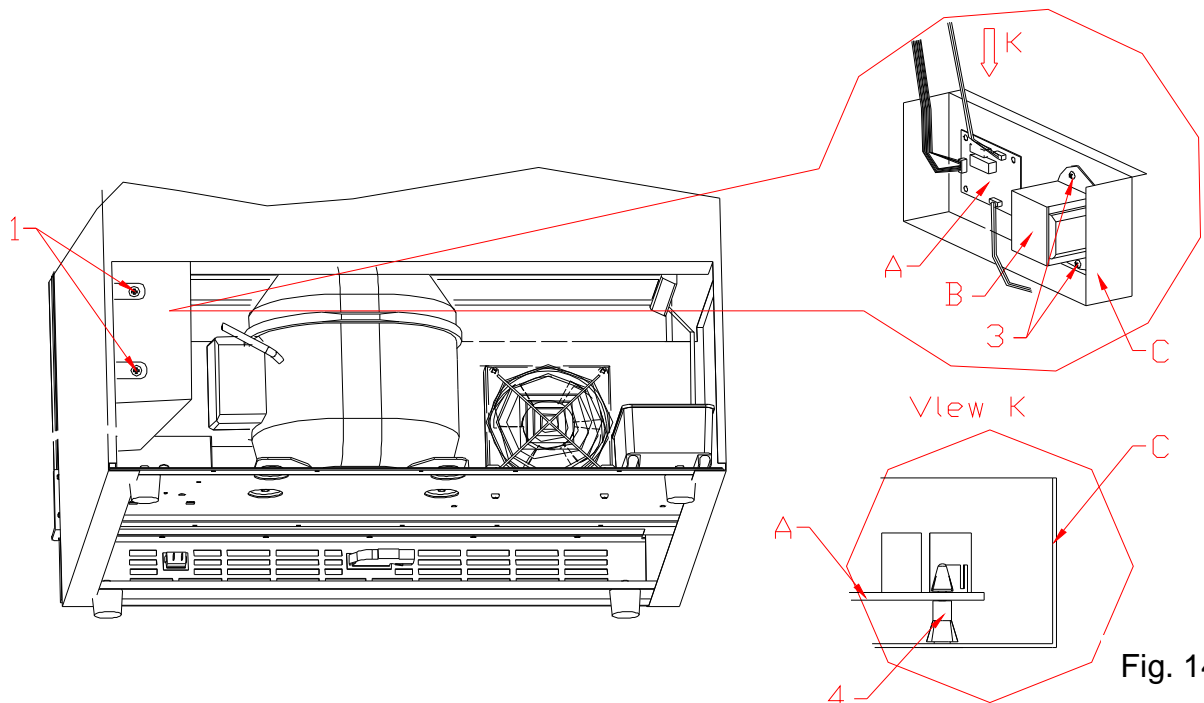
Fig. 14

- 1 >. Remove the 2 screws (1); ( Fig.14)
- 2 >. Remove the electrical box; ( Fig.14)
- 3>. Unplug all the connectors, then press the head of each of the four plastic screws (4), move up-ward the power PCB (A), then replace a new one. ( Fig.14) (View K)
- 4>. Plug all the connectors; ( Fig.13)
- 5>. Remove the 2 screws (B) and transformer, then replace a new transformer.( Fig.14)
