DD120BK

Caple Downdraft 120cm hood

Technical information

Down Draft Trouble Shooting Guide

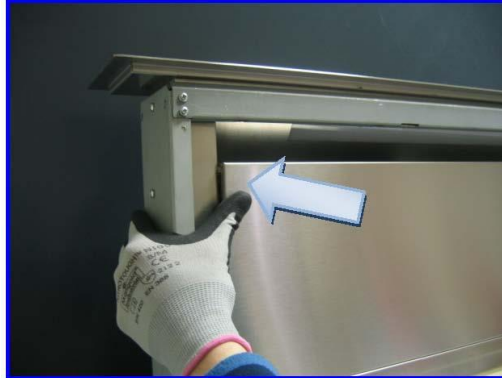
Hook it again, by pressing simultaneously on both sides of the panel.

After having remounted the body front panel, and before placing the downdraft again into the cabinet, we recommend checking the downdraft operation.

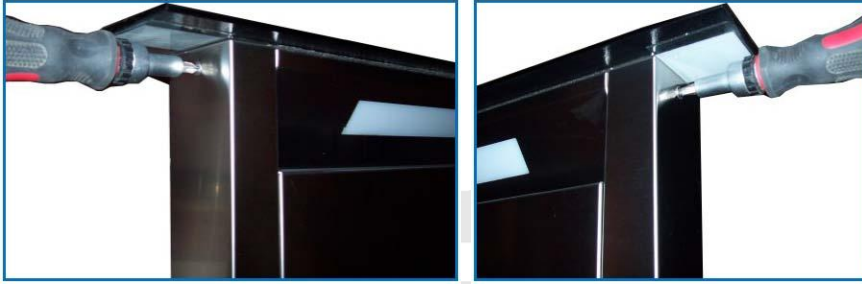
Remove the upper front panel by unscrewing the two socket head screws found on the right and left side of the cooker-hood

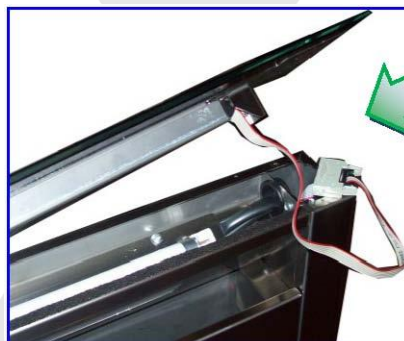
Lift the front panel up, paying attention to the push button panel flat cable, disconnect the flat connector and remove the front glass panel in order to avoid any possible damage.

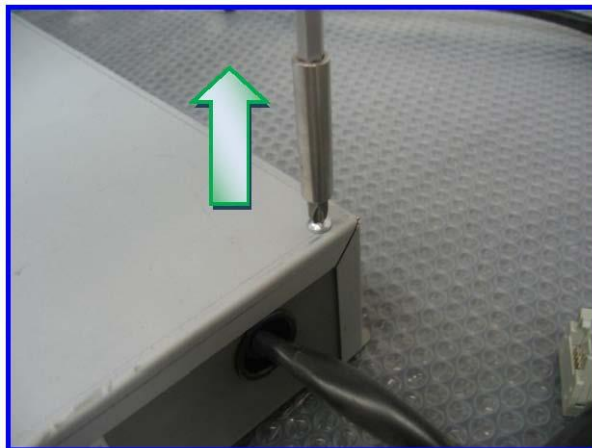
Remove power supply by disconnecting the plug from the mains. Remove the control box cover by unscrewing the 4 screws.

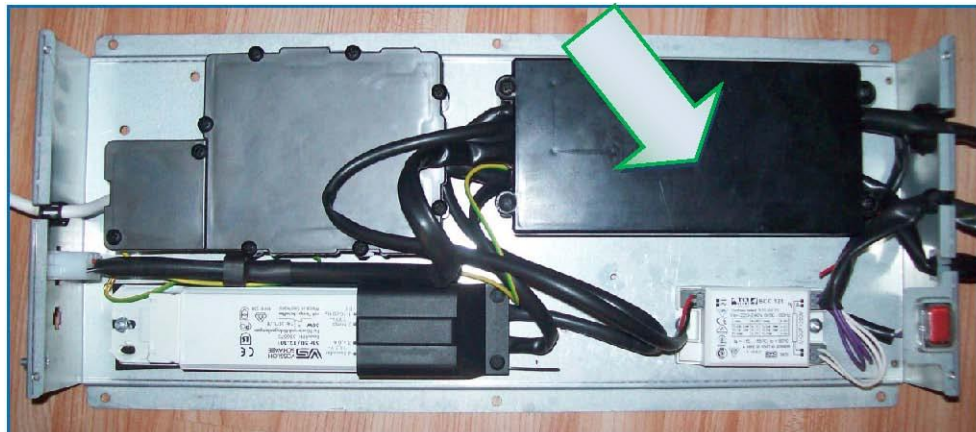
Find the main board box

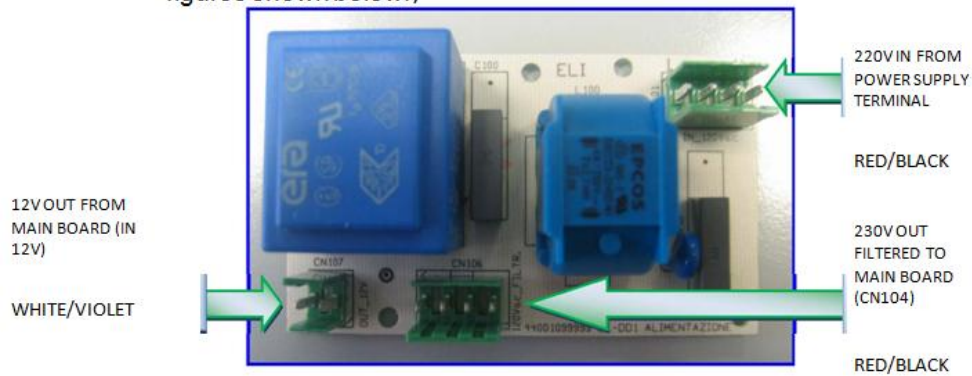
Disconnect a connector a time **making sure to properly reconnect them in the new board (use the wiring diagram and figures shown below.)**

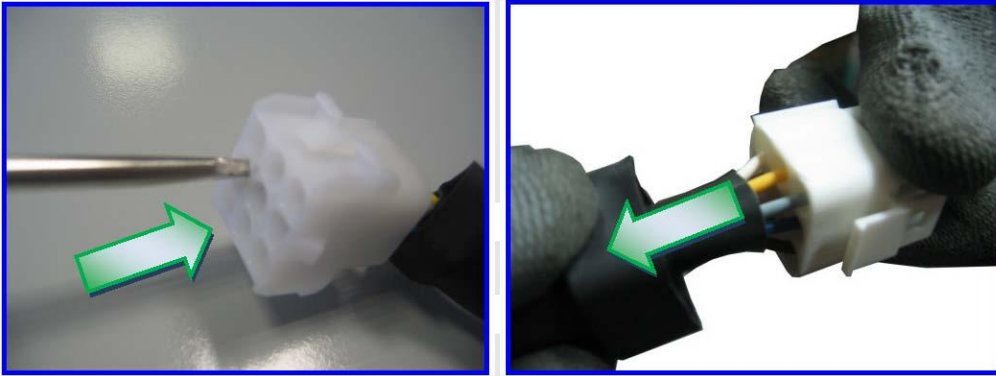
Check if the connector is inserted properly, pull the sheath outwards and make sure the wires are well inserted into the connectors, according to the colours scheme shown in the figure below.

“It may happen that the connector pins, due to overpressure during their insertion, come out of their seat preventing the electric connection from being performed. With the help of a tool, check if the pins are properly connected.”

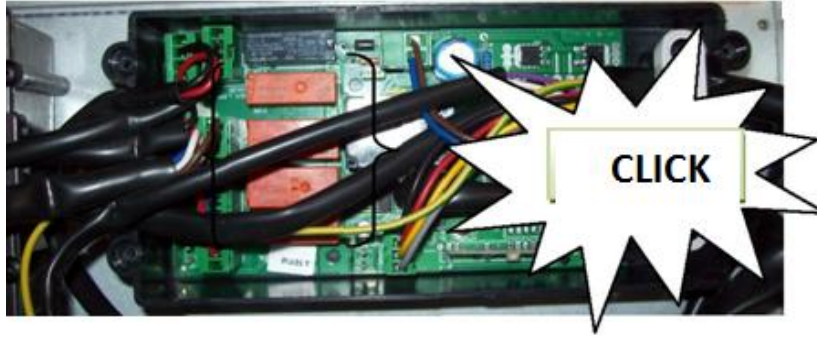
Open the electric system box and check if the motor relays are switching over.

“When pressing the speed variation key a “CLICK” should be heard ”

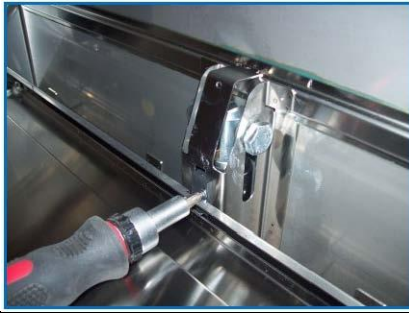
Take a magnet and place it close to the sensor , then repeat the test using a tester: the circuit should be closed at this point
If without the use of the magnet, the circuit is closed, carry a screwdriver -head screwdriver and move the position of the sensor down.

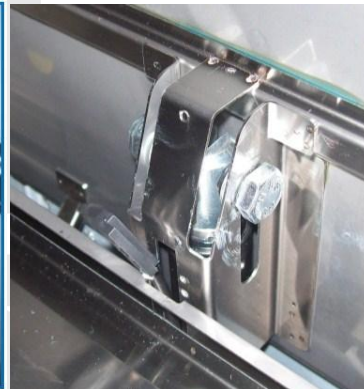
If the circuit is still closed after having moved the sensor, you need to replace the sensor. Unscrew the two screws, cut all of the sensor cable fixing clamps and remove the sensor by pulling it from the bottom

(Since the magnet shall be placed in the same position of the damaged one, carefully check the cable, clamps and sensor position before removing the magnet.)

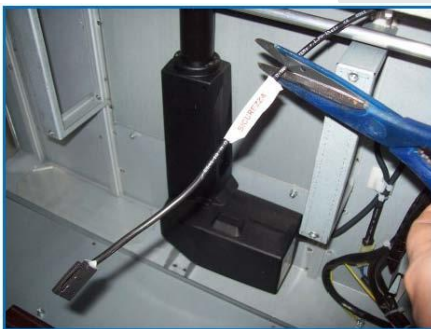
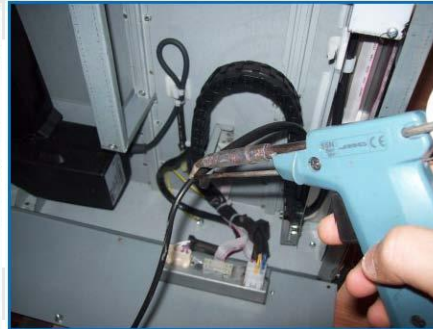
Then cut the sensor cable and replace it with a new one, soldering the wires and insulating the joints.

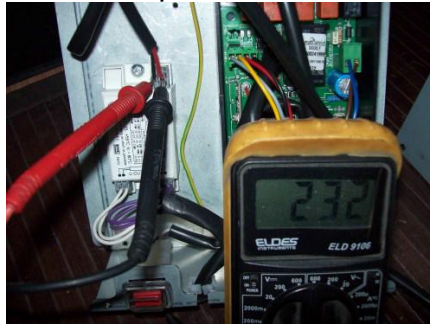
Place the test probes at the ballast input and check if there is 230V.
