# DD600\*\*

Downdraft 60cm hood

# TECHNICAL INFORMATION

# **TROUBLE SHOOTING PROBLEM**

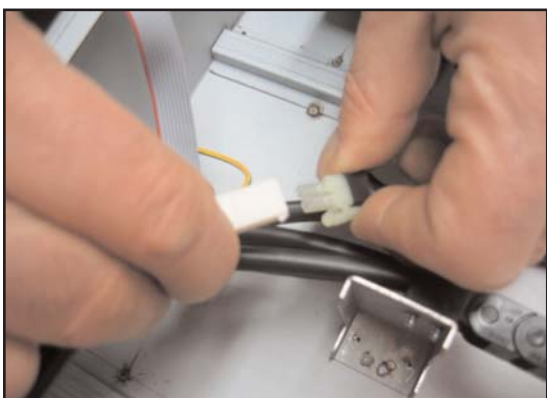
9.1 Check if the 2-pole connector, for the actuator power supply (A), is inserted properly

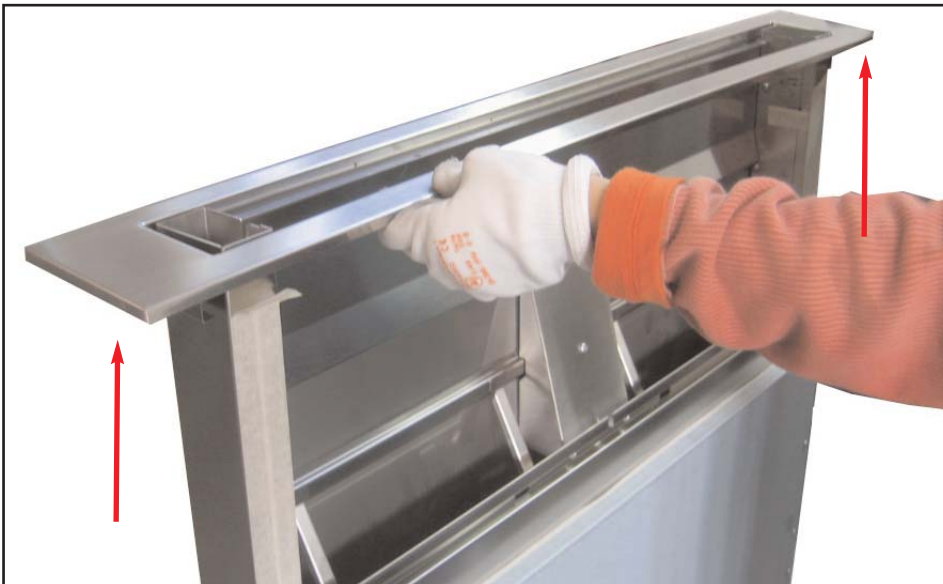
**13.12 Take the body liner out and replace it with a new one**

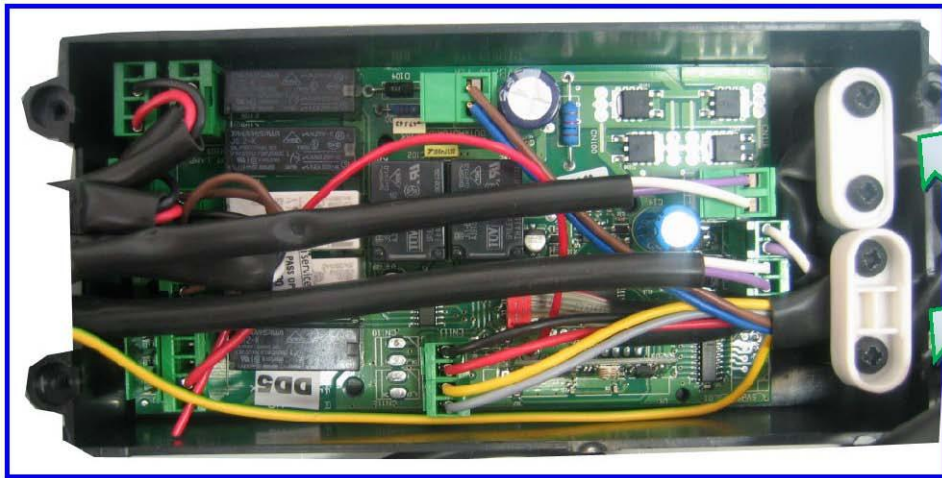
Remove the Lid

Disconnect one connector at a time **making sure to reconnect them properly** on the new board (use the wiring diagram, or take a photo) For the replacement of the PCB use the spare parts list of the model in question.

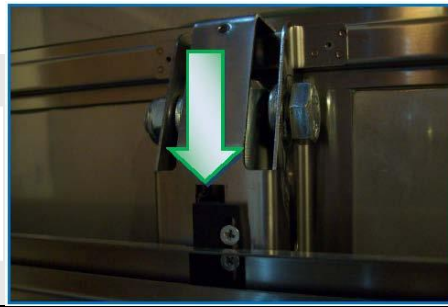
Take a magnet and place it close to the sensor , then repeat the test using a tester: the circuit should be closed at this point  
If without the use of the magnet, the circuit is closed, carry a screwdriver -head screwdriver and move the position of the sensor down.

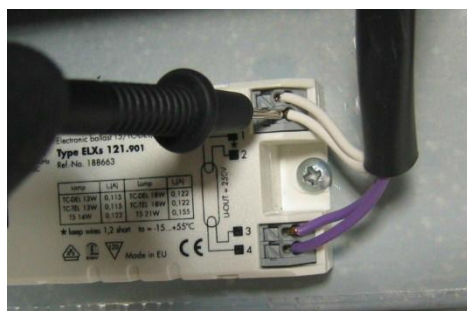
Place a test probe in one of the neon tube holder's contacts and check the ballast continuity inside the electric system box.
