DD605SS

Downdraft extractor

Technical information

DD605SS - Caple Downdraft extractor

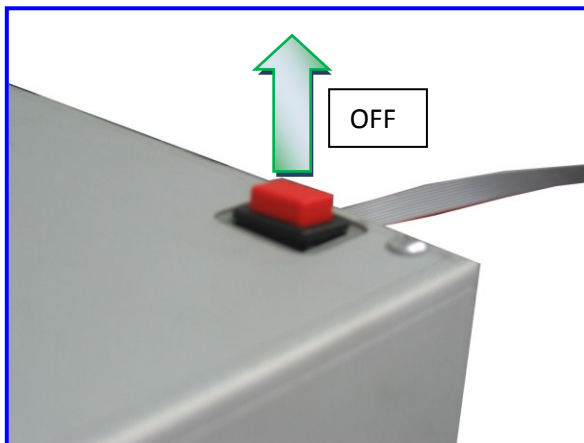
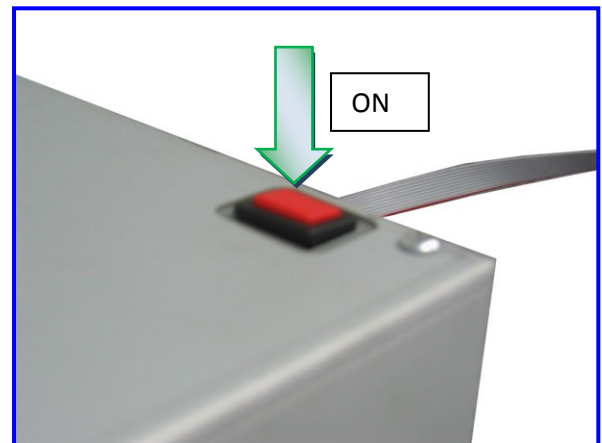
CHECK IF THE RED POWER BUTTON IS IN ON POSITION

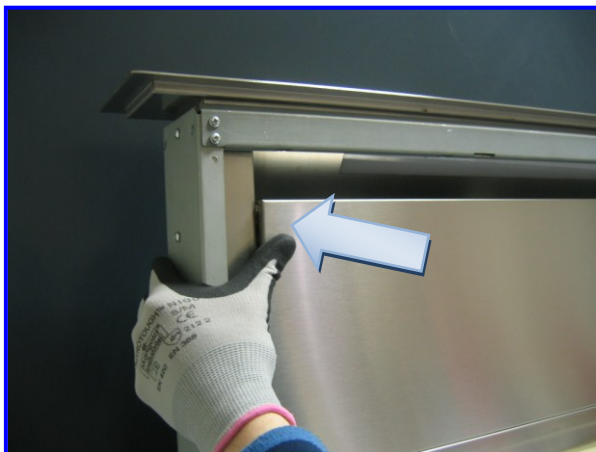
- Hook it again, by pressing simultaneously on both sides of the panel.

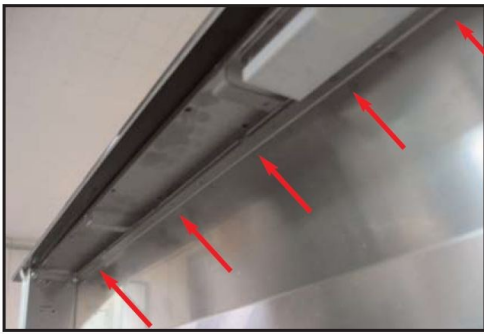
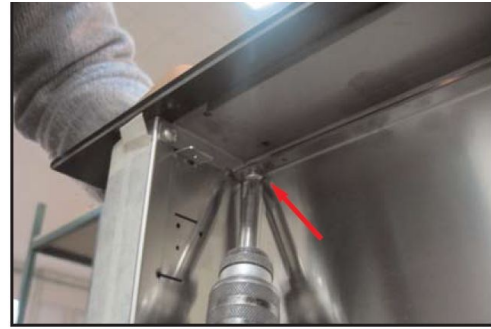
Take the under head 5 screws and the two lateral screws out.

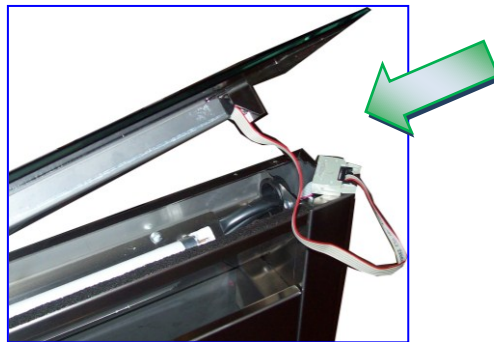
- Lift the front panel up , paying attention to the push button panel flat cable , disconnect the flat connector and remove the front glass panel in order to avoid any possible damage.

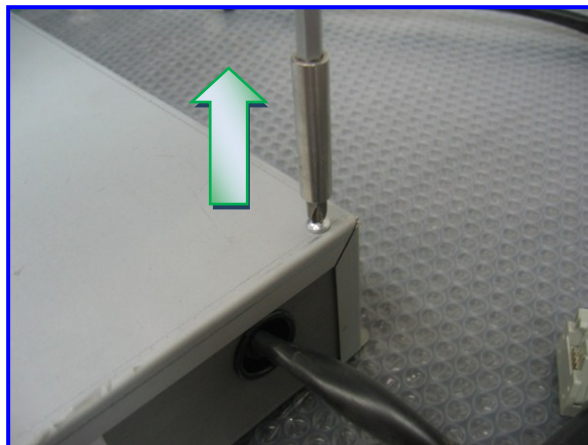
- Remove power supply by disconnecting the plug from the mains or by opening the magneto-thermal switch if present.
- Remove the electric system box cover by unscrewing the 4 screws.

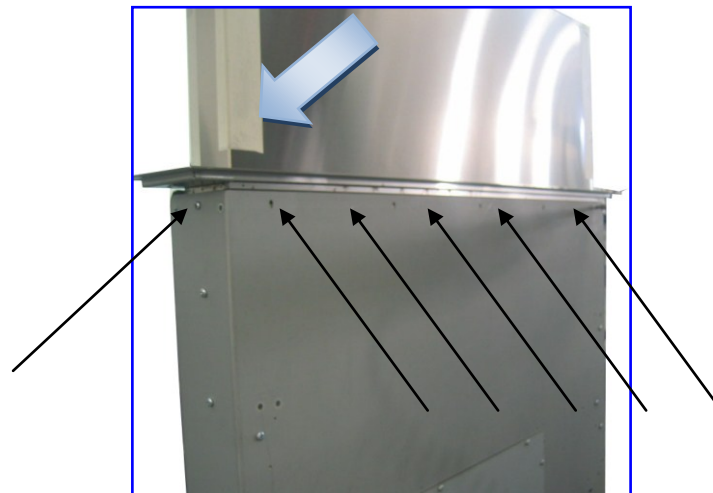
- Nella parte posteriore e laterale togliere le viti che fissano il bordo carcassa.

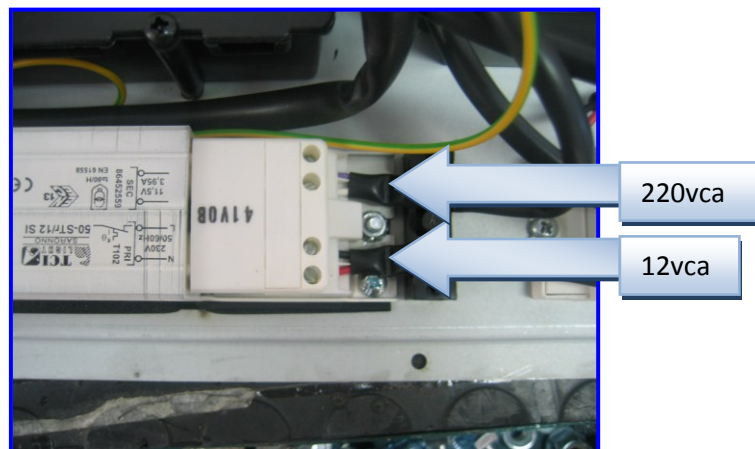
- Check if there are 220V in the transformer primary and about 12V in the transformer secondary.

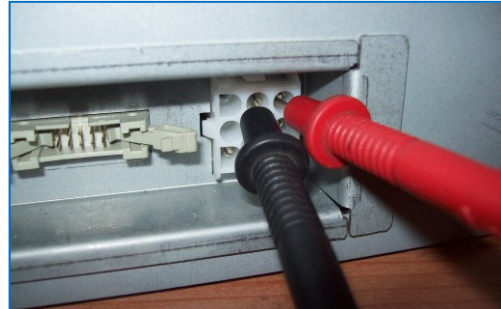
- To check the sensor proper working, you need to place the tester rods at the Yellow and Grey wires of the 9-pole fixed connector . If the sensor works properly the tester should show an open circuit

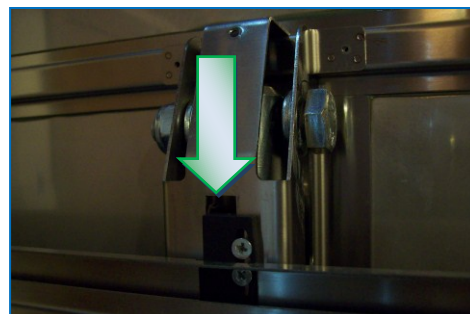
- Take a magnet and place it close to the sensor , then repeat the test using a tester : the circuit should be closed at this point.
- **Se senza l'utilizzo del magnete il circuito è chiuso, munirsi di un giravite con punta a croce e spostare la posizione del sensore verso il basso.**

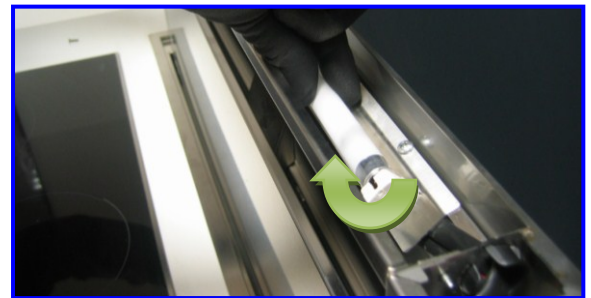
- Remove the neon tube and replace it with a new one.

NARVA
LT 14WT5/865 cool daylight
www.narva.be

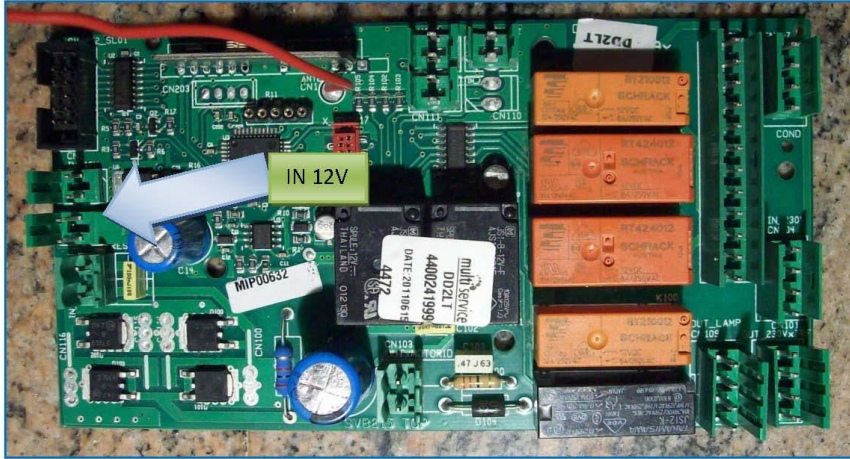
About 12 V should be found also in the CN102 board connector

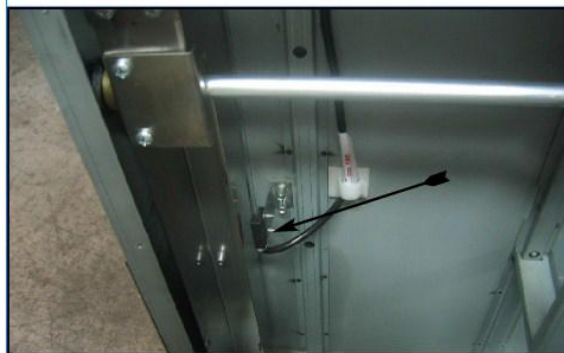
Remove the 180mm sensor fixing screws
