DD606BK

Downdraft 60cm hood

Technical information

Down Draft Trouble Shooting Guide

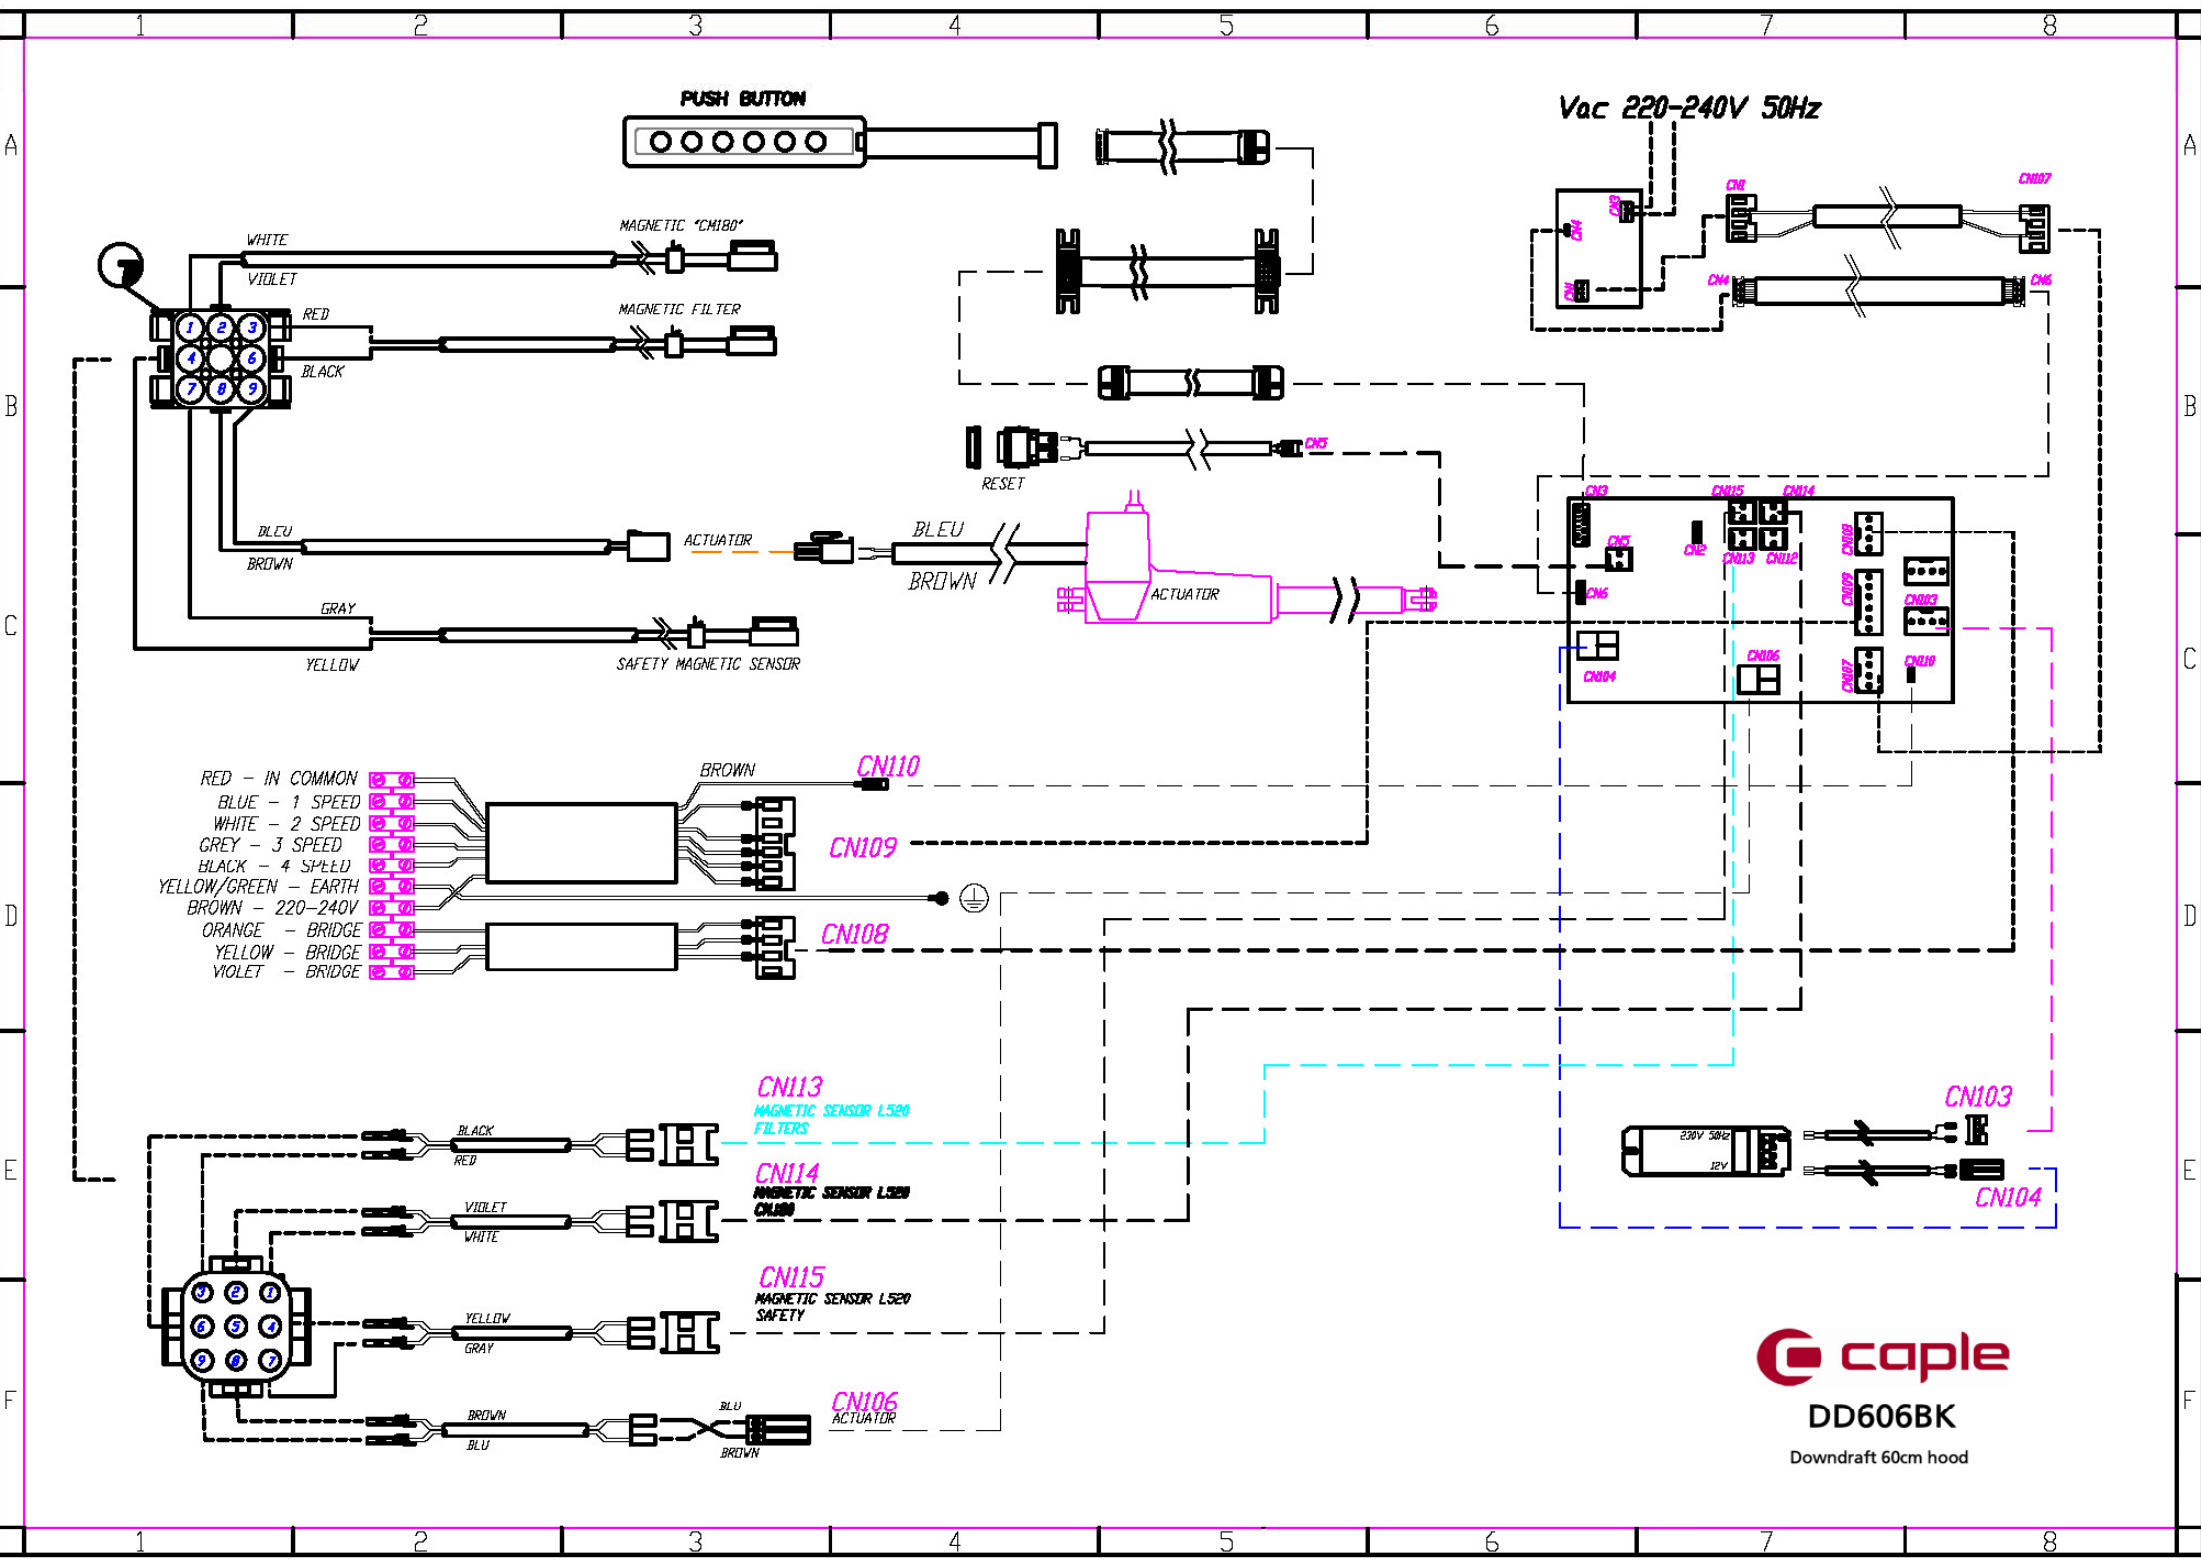
Item	Part Number	Description	Quantity
1	75072099999	300MM ACTUATOR	1
2	75075030309	TRANSFORMER 220-240V 50Hz 50W	1
3	75004249999	WIRING BOARD	1
4	75075034398	MAIN PCB	1
5	75180030400	GEAR	1
6	75180030153	GEAR ROD	1
7	75181734380	SLIDE M4 TYPE	1
8	75075030312	MAGNETIC SENSOR	1
9	75071505034	ALUMINIUM FILTER	1
10	77025011279	PANEL WITH MAGNETS	1
11	75042206201	BLACK GLASS TOP PANEL TO 06/2016	1
11	75042206287	BLACK GLASS TOP PANEL FROM 09/16	1
12	75070020012	FIXING KIT	1
13	75501000015	BRASS ROD BUSH	1
14	75042964553	MAGNET	1
15	75027999999	FLATCABLE TO 06/2016	1
15	75074516366	FLATCABLE	1
16	75074516018	CHAIN	1
17	75021001097	FRONT JOINT	1
18	75021002083	WELDED CHIMNEY CONNECTION	1
19	75470199999	EMERGENCY SWITCH/START NEON	1
20	75002311165	LINER	1
21	75025100335	BUTTONS 6A	1
22	75036099999	RACK (2 pcs)	1
23	75096000553	MAGNET 20X3	1
24	75025100150	MAGNETS AND SAFETY SWITCH HOLDER	1
25	75119250699	WIRING ASSEMBLY	1
26	75023899999	FLAT CABLE	1

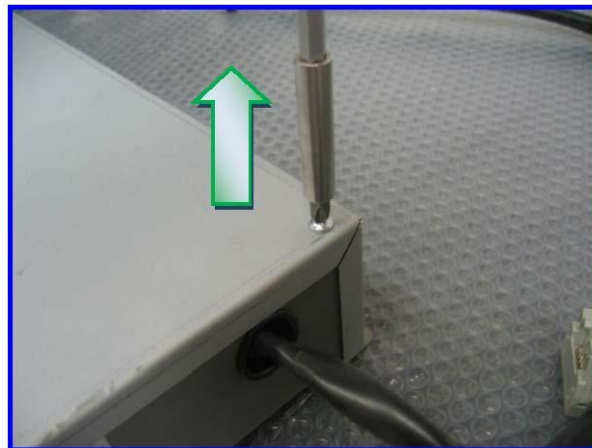
Remove power supply by disconnecting the plug from the mains. Remove the control box cover by unscrewing the 4 screws.

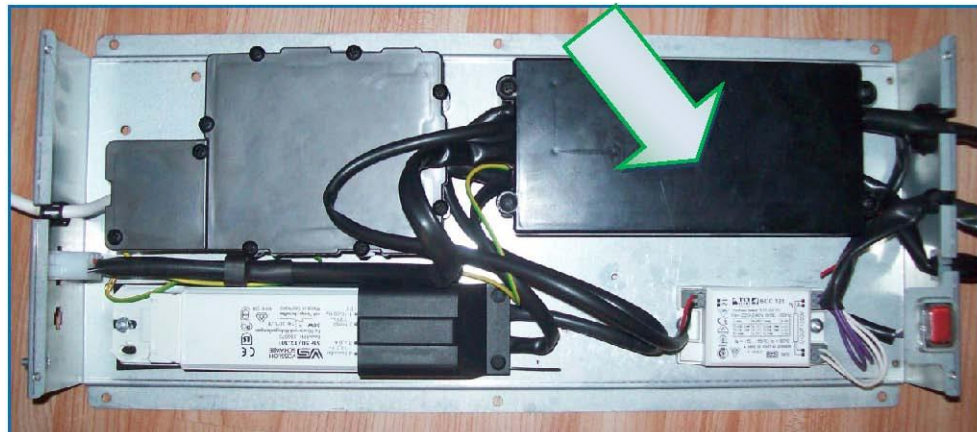
Find the main board box

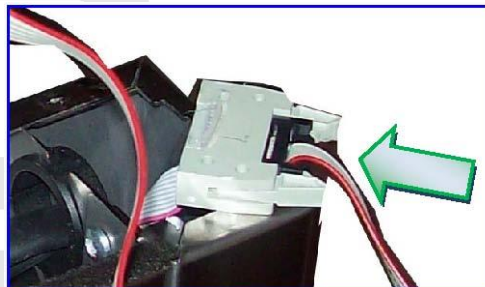
Check if the push-button panel ribbon cable is properly connected to the main board.
Push Connection SDD2 Push Connection SDD2-L

Check if the ribbon cable inside the right column of the extractable unit is properly connected to the connector. You need to remove the upper front side to carry out this operation

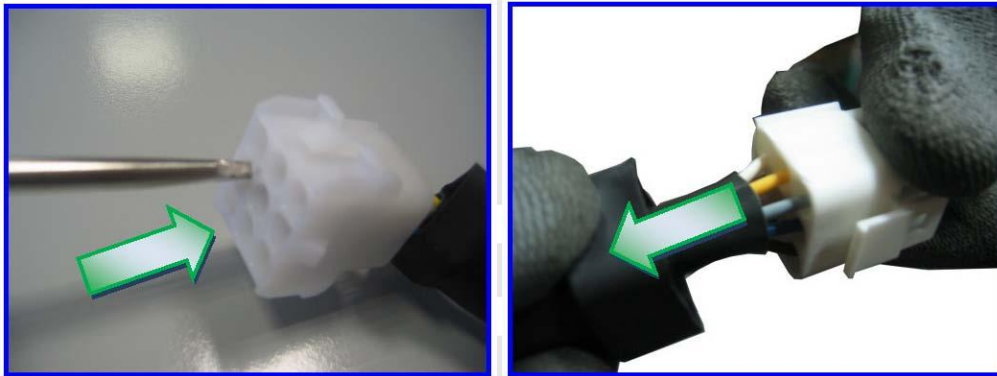
Check if the connector is inserted properly, pull the sheath outwards and make sure the wires are well inserted into the connectors, according to the colours scheme shown in the figure below.

“It may happen that the connector pins, due to overpressure during their insertion, come out of their seat preventing the electric connection from being performed. With the help of a tool, check if the pins are properly connected.”
