DD900**

Downdraft 90cm hood

TECHNICAL INFORMATION

TROUBLE SHOOTING PROBLEM

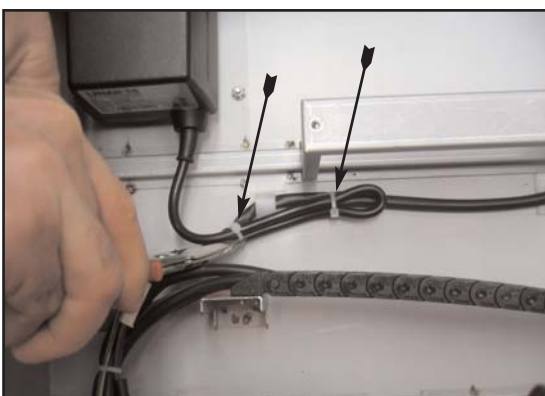
14.11 Take the two clamps of the actuator cable out

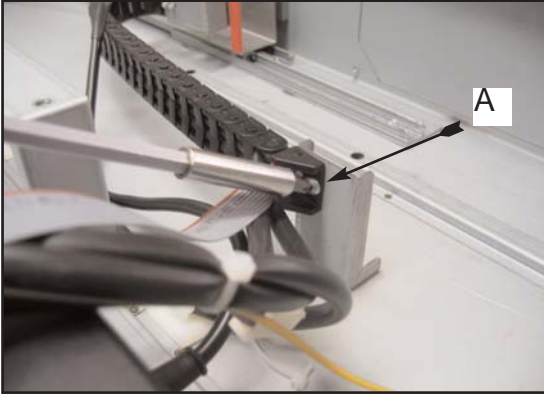
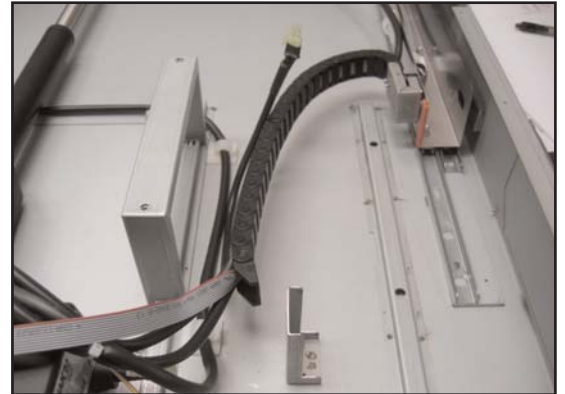
14.12 Take the 2 fixing screws of the chain out (A) paying attention not to damage the cables

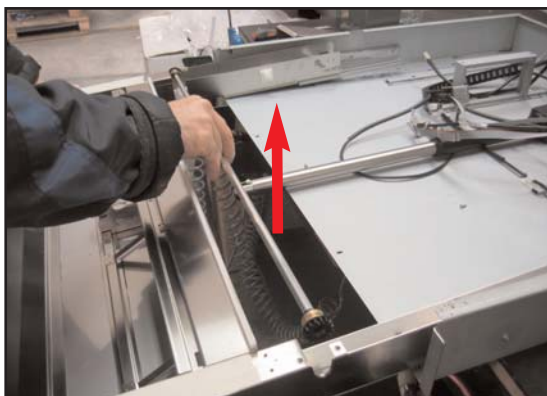
14.25 Take the rack rods out

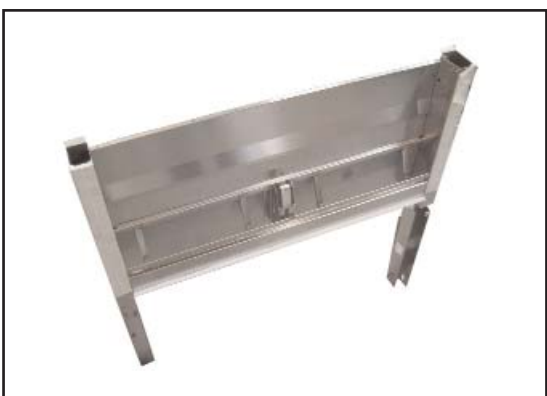
14.26 Take the new extractable unit paying attention not to damage it

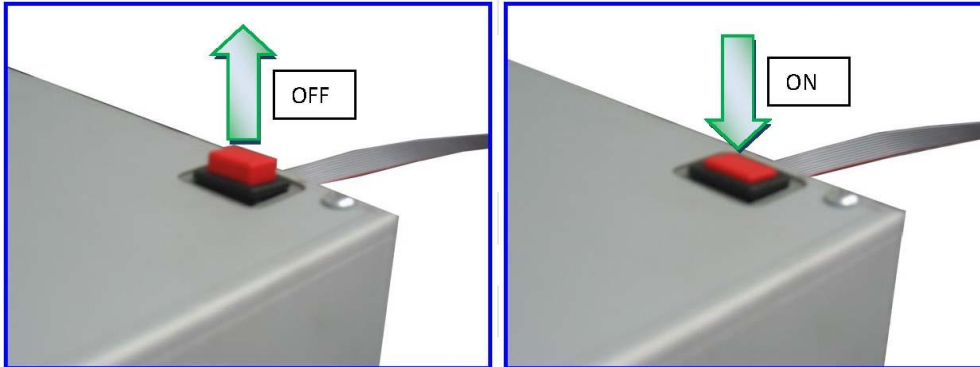
- **CHECK IF THE RED POWER BUTTON IS IN THE ON POSITION**

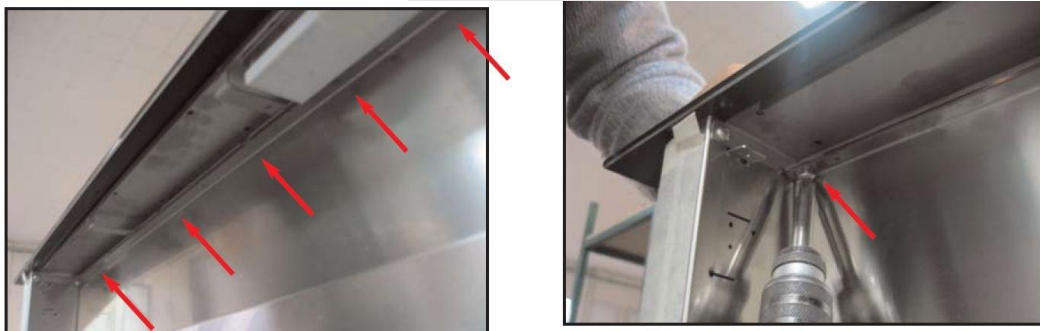
Take the 5 screws underneath and the two side screws out.

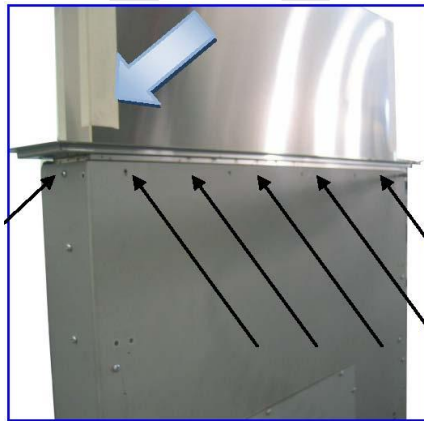
On the back and side remove the screws that hold the edge carcass.

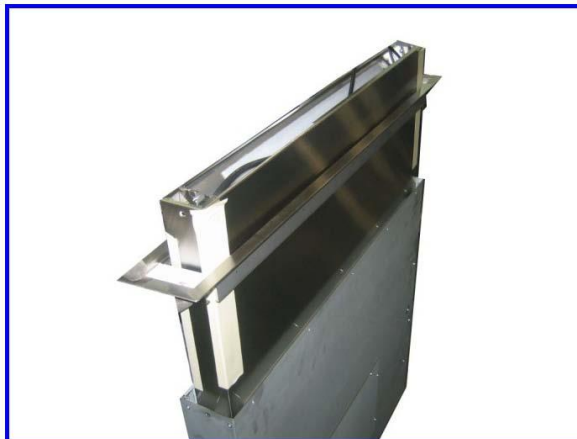
Remove the body liner.

Before removing the body liner from the extractable unit, we recommend to use protective adhesive strips in order to avoid the extractable unit getting scratched
Note: There are two type of edge casing standard one and that FLUSH TOP, first to remove the edge casing make sure the spare is correct. For both models:

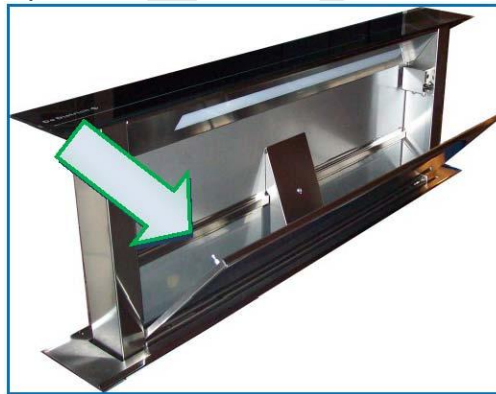
Open the front panel to make sure the sensor is not damaged,

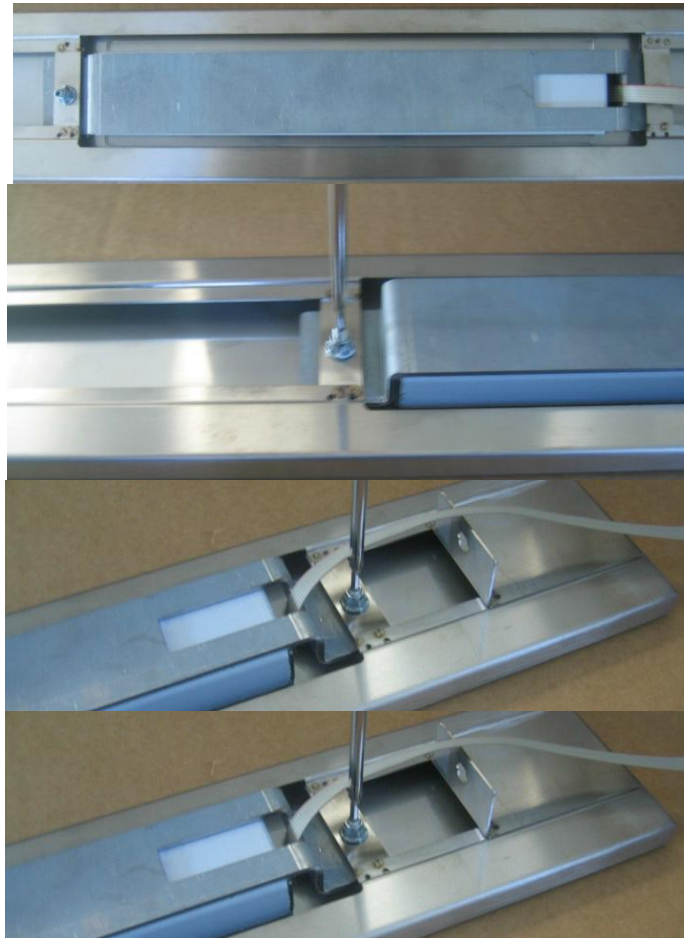
Unscrew the two dowels which fix the push-button bracket.

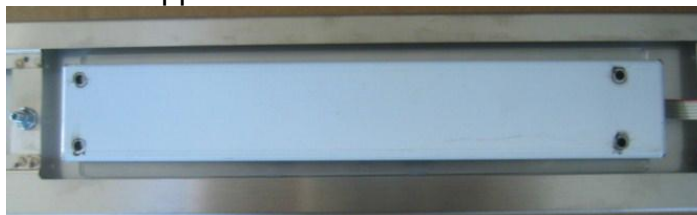
Remove the push-button support

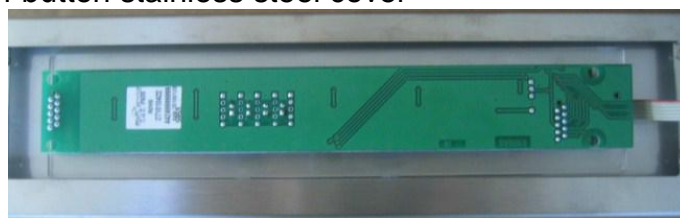
Remove the push-button stainless steel cover

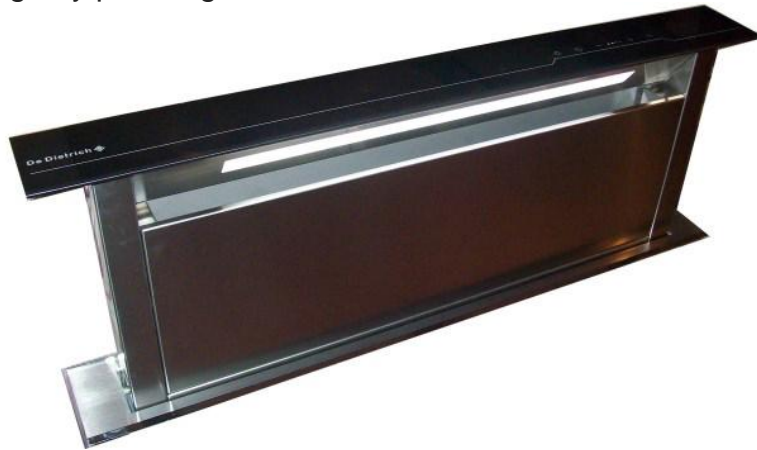
Raise the carriage by pressing the ON button and then remove the mains power.
