DD900SS

Caple Downdraft 90cm Stainless Steel

DD900SS - Caple Downdraft hood

TROUBLE SHOOTING PROBLEM

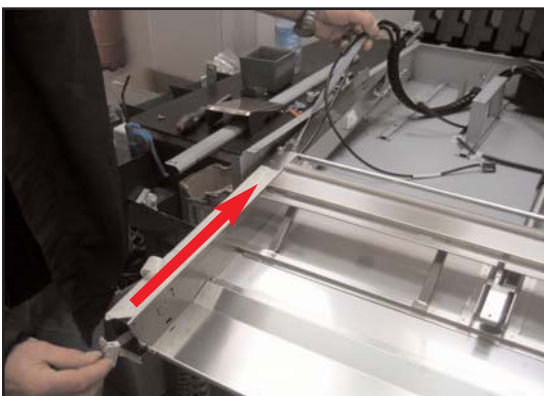
6.4 Take the sensor cable out from the lower side column and replace it with a new one

ATTN: The sensor cable must be cut and the new sensor wires must be welded in.

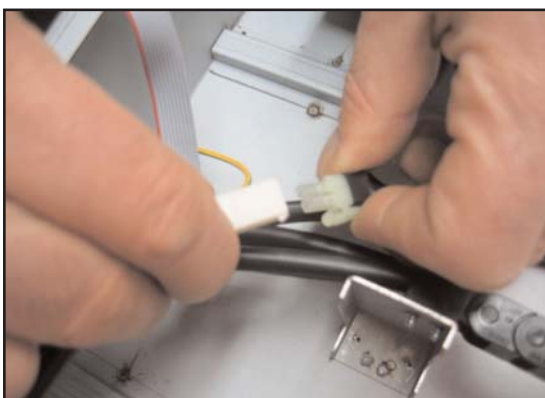
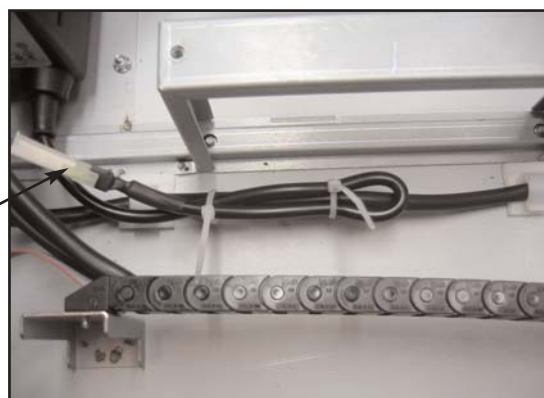
9.1 Check if the 2-pole connector, for the actuator power supply (A), is inserted properly

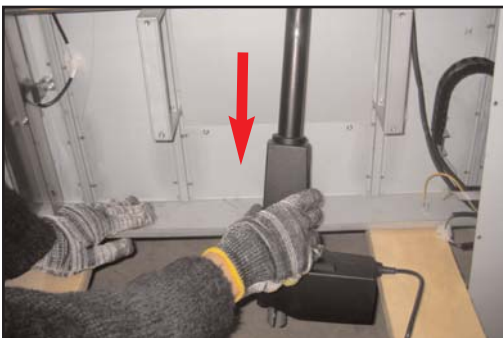
10.8 Disconnect the actuator from the extractable unit by taking the M8 screw (A) out, using two 17 mm keys.

10.9 Remove the actuator from the lower side of the downdraft

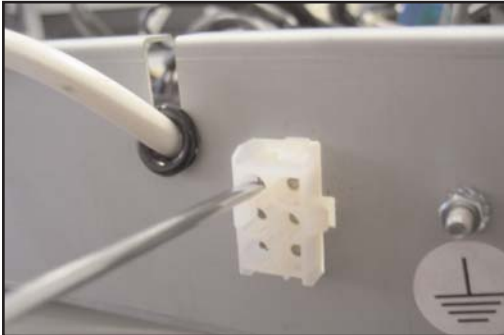
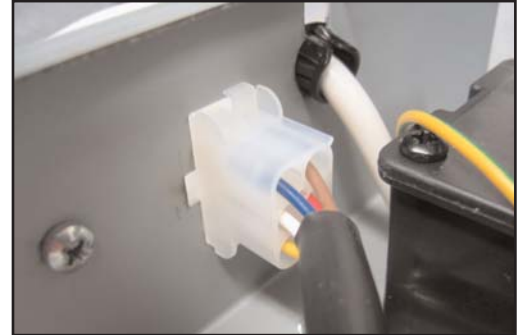
11.1 With the help of a suitable tool, check that the inner contacts of the fixed connector, placed in the electrical system box, as well as the movable connector, found in the suctioning unit, are all inserted properly.

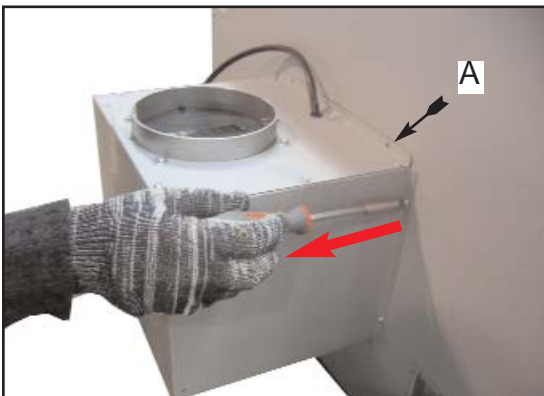
12.3 Dismount the suctioning unit, by taking the no.8 screws (A) out, and replace it with a new one.

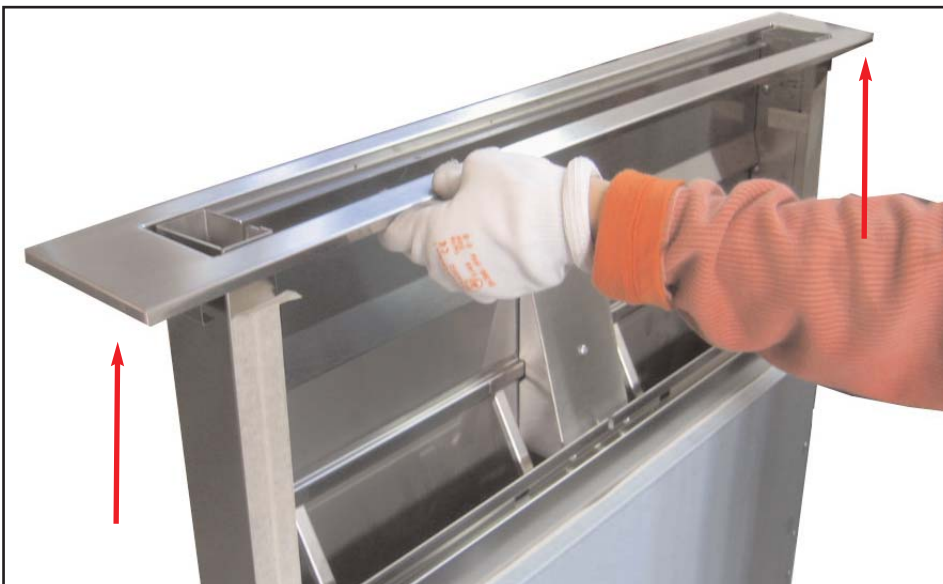
13.12 Take the body liner out and replace it with a new one

ATTN: THE BODY LINER MUST BE CENTERED COMPARED TO THE EXTRACTABLE UNIT

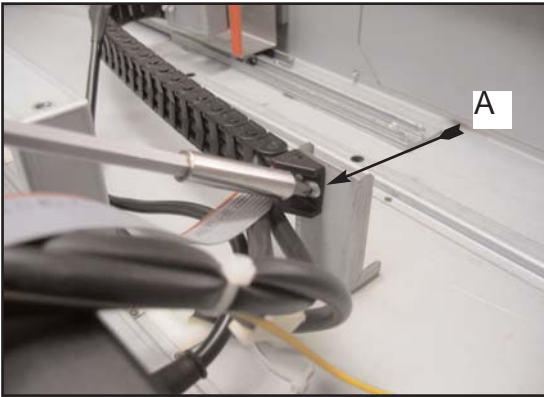
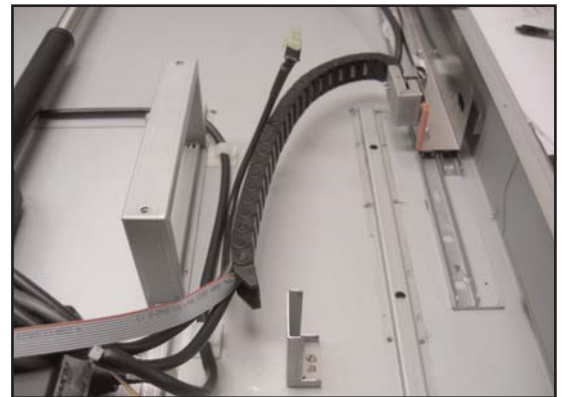
14.12 Take the 2 fixing screws of the chain out (A) paying attention not to damage the cables

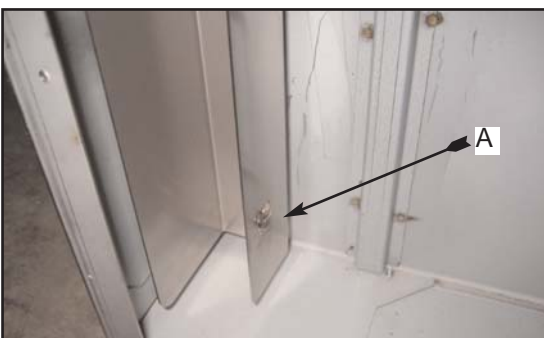
15.4 If the sensor is working properly, when the extractable unit reaches 180 mm of height in the multimeter, some seconds of electric continuity must be noticed.

15.5 If there is no electric continuity, check if the magnet (A) in the extractable unit column is placed properly.

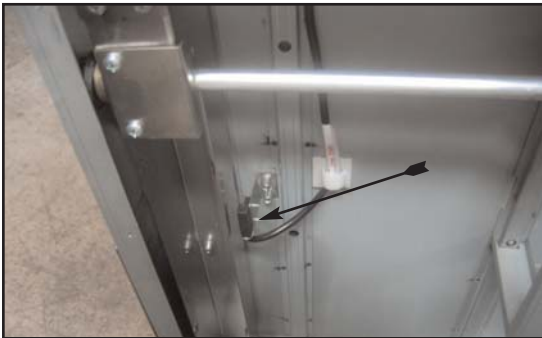
16.3 Remove the 180mm sensor fixing screws

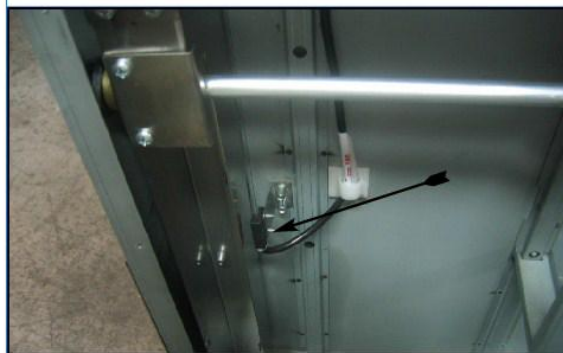
Remove the 180mm sensor fixing screws
