# DD901BK

Push Downdraft 90cm hood

## Technical information

## **Down Draft Trouble Shooting Guide**

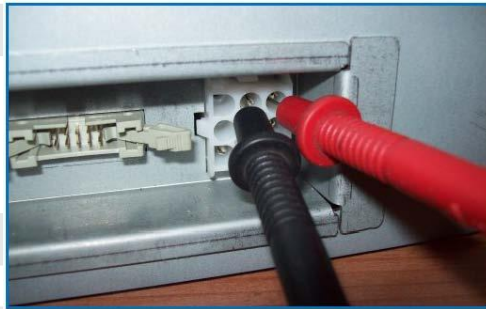
To check the sensor proper working, you need to place the tester rods at the Yellow and Grey wires of the 9-pin fixed connector. If the sensor works properly the tester should show an open circuit

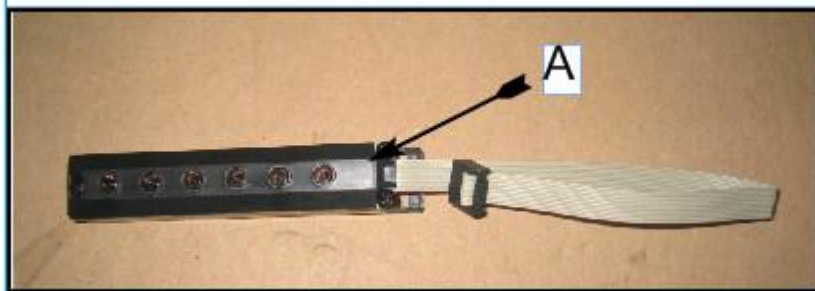
- Remove the upper front panel as shown in previous Chapters.
- The push-button panel that CAPLE supplies as a spare part is equipped with a Ribbon cable and a connector (A)
