DD905BK

Downdraft extractor

Technical information

Trouble shooting

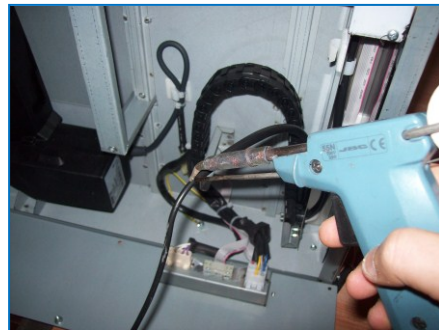
- Then cut the sensor cable and replace it with a new one, welding its wires with a soft-soldering welder.
