**DD910\*\***

**Downdraft 90cm hood**

**Instruction Manual**

# **TROUBLE SHOOTING PROBLEM**

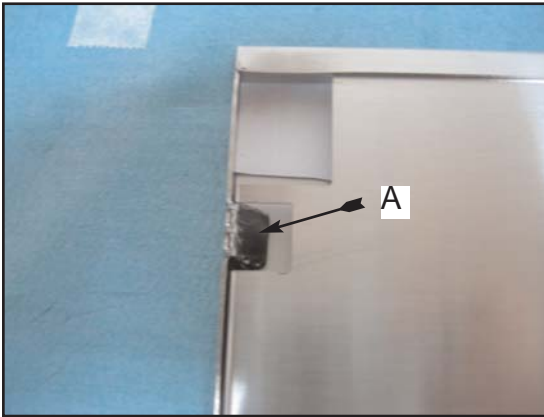
5.3 In order to make sure the sensor is working properly, place another magnet close to the sensor and run the continuity test again.

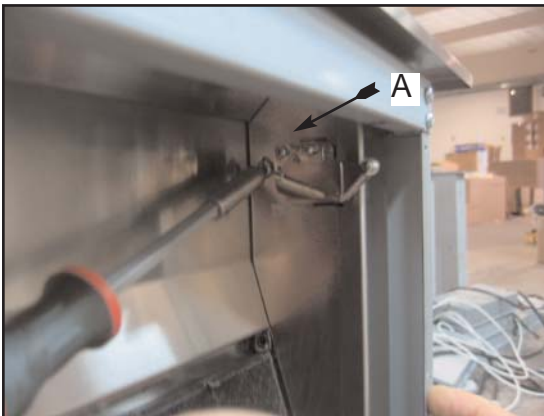
6.3 Remove the sensor bracket screw (A) from the right column of the extractable unit.

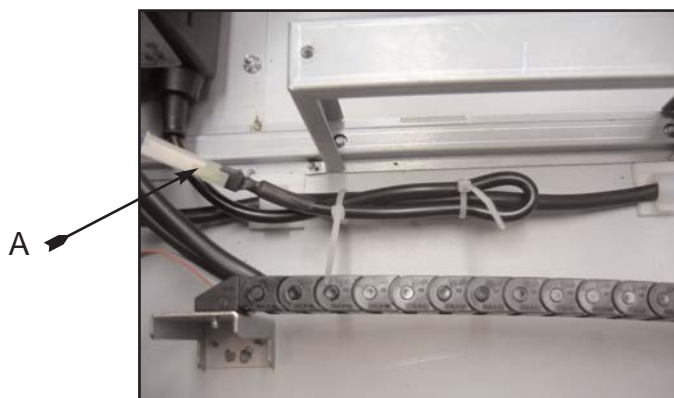
9.1 Check if the 2-pole connector, for the actuator power supply (A), is inserted properly

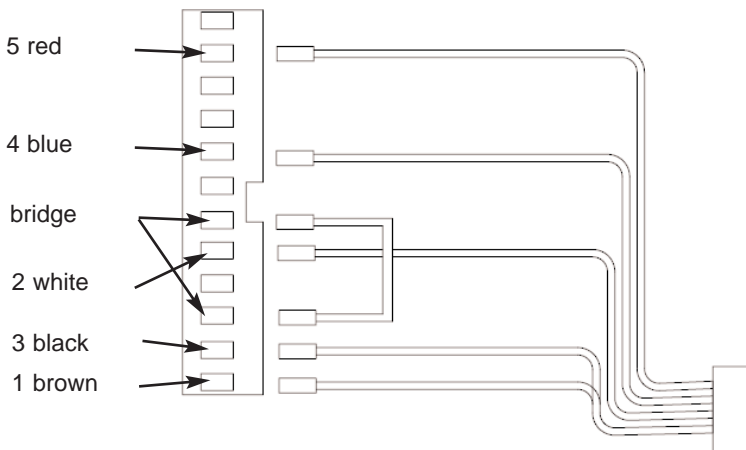
11.3 IF A LN2 GPZ800 MOTOR IS USED, check the connections with the following diagram:

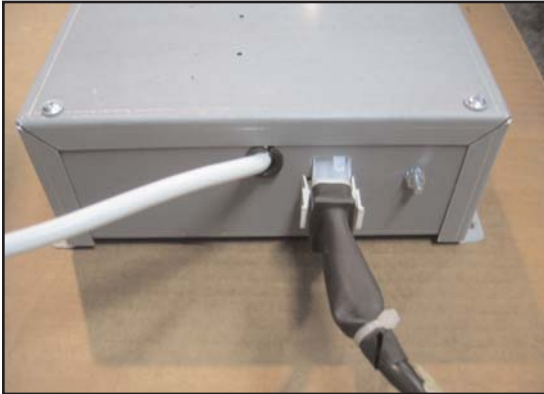
**12.2 Remove the 9-pole connector from the suctioning unit**

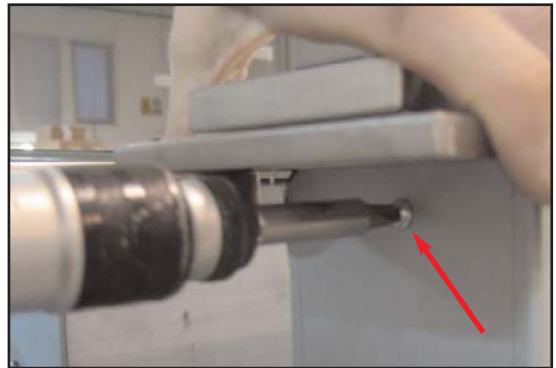
**13.11 Take the 5 screws on the body liner and the 2 lateral screws out**

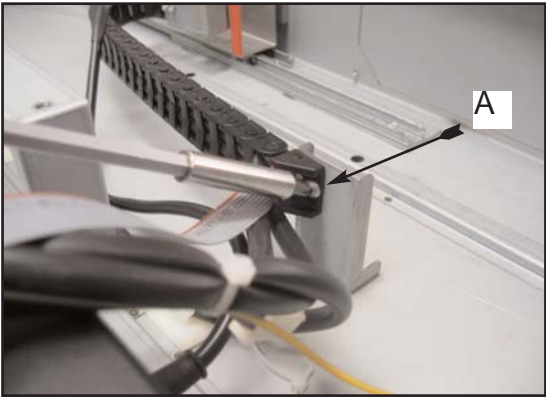
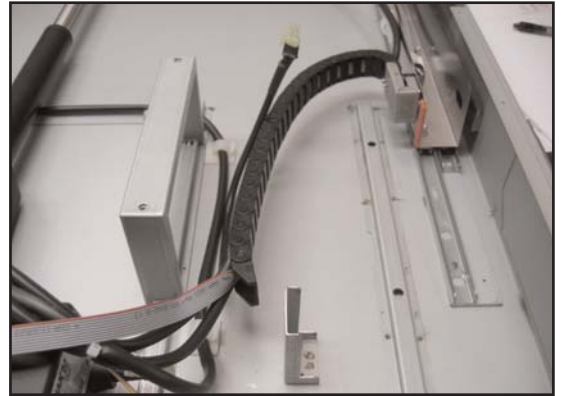
**14.12 Take the 2 fixing screws of the chain out (A) paying attention not to damage the cables**

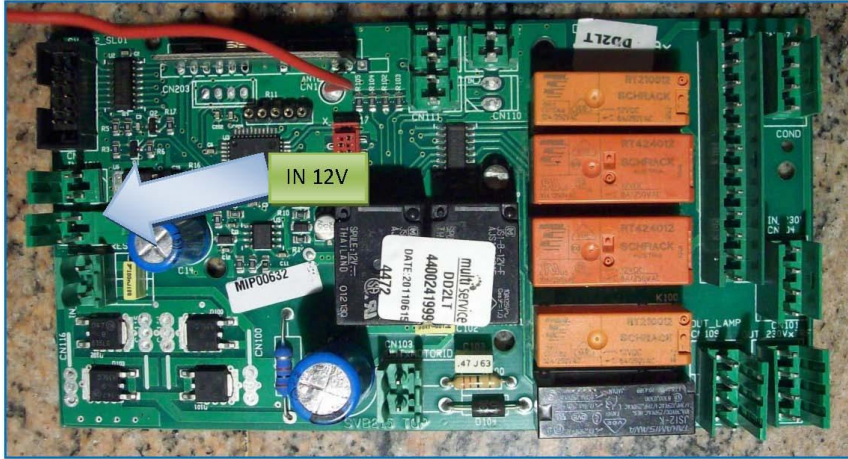
About 12 V should be found also in the CN102 board connector

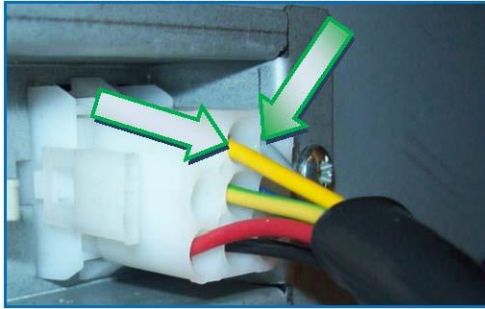
To check the sensor proper working, you need to place the tester rods at the Yellow and Grey wires of the 9-pin fixed connector. If the sensor works properly the tester should show an open circuit

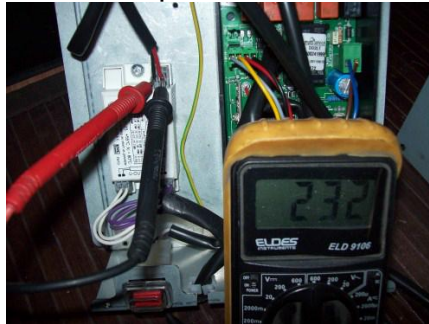
Place the test probes at the ballast input and check if there is 230V.
