DD911BK

Downdraft 90cm hood

Technical information

Down Draft Trouble Shooting Guide

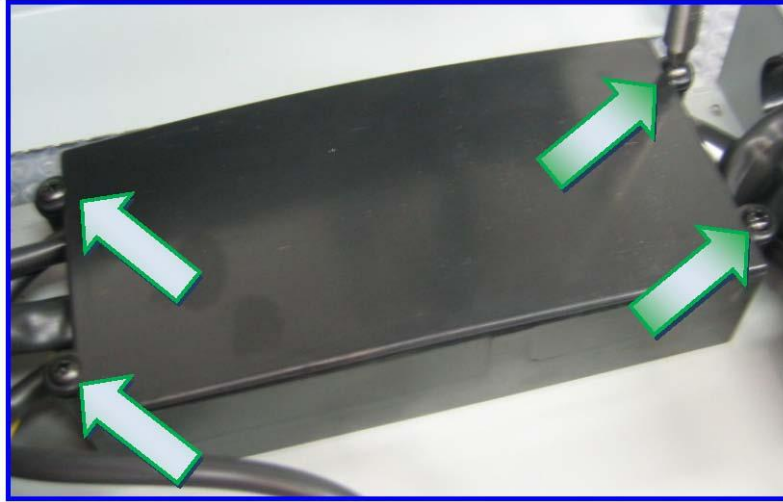
Remove the 4 screws in the plastic cover.

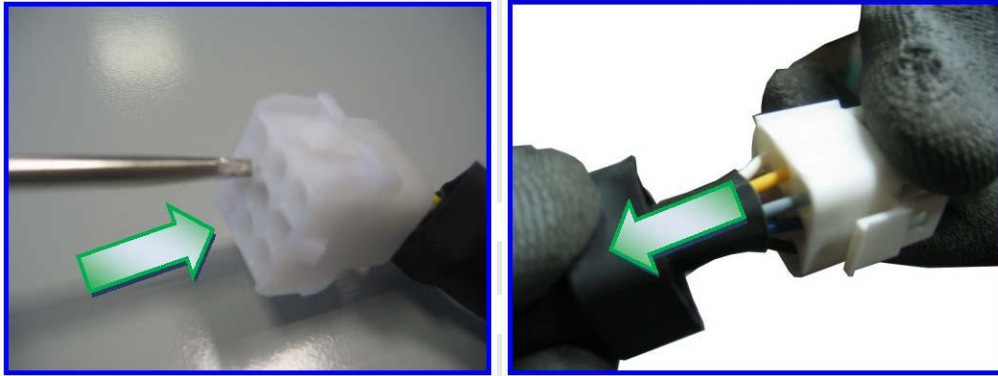
Check if the connector is inserted properly, pull the sheath outwards and make sure the wires are well inserted into the connectors, according to the colours scheme shown in the figure below.

“It may happen that the connector pins, due to overpressure during their insertion, come out of their seat preventing the electric connection from being performed. With the help of a tool, check if the pins are properly connected.”

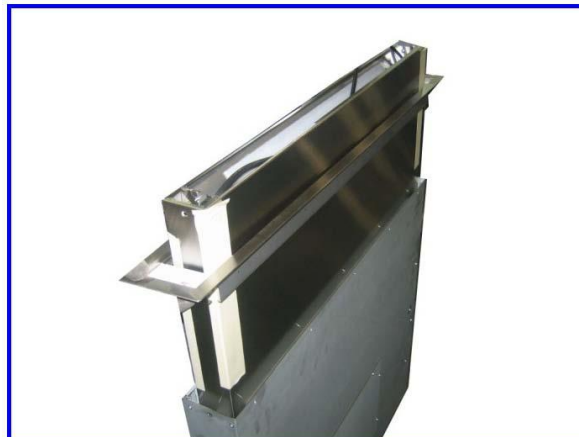
Remove the body liner.
