DD920BK

Downdraft 90cm flip hood

Technical information

Trouble shooting

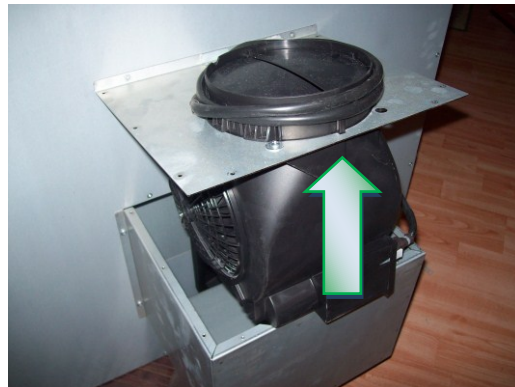
- Remove the fixing screws from the fan support plate and lift the suctioning unit up

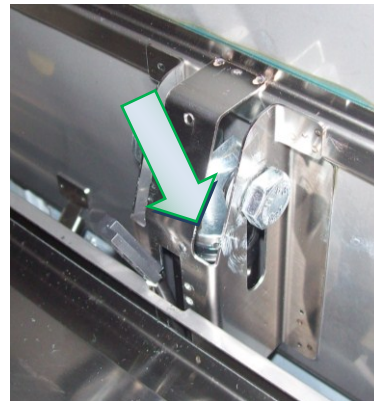
- If the circuit is still closed after having moved the sensor, you need to replace the sensor . Unscrew the two screws, cut all of the sensor cable fixing clamps and remove the sensor by pulling it from the bottom.

(Since the magnet shall be placed in the same position of the damaged one, carefully check the cable, clamps and sensor position before removing the magnet.)

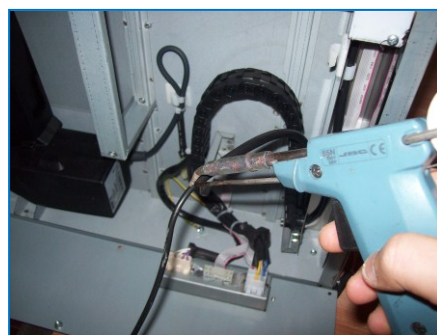
- Then cut the sensor cable and replace it with a new one, welding its wires with a soft-soldering welder.

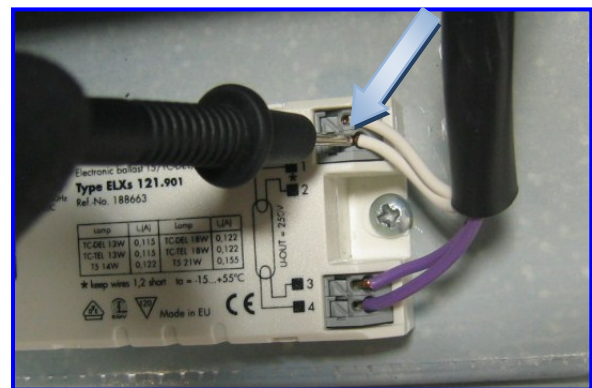
- Carry out an electric continuity test between the neon tube holders and the ballast inside the electrical system box.
- Place a test prod in one of the neon tube holders contacts and check the ballast continuity inside the electric system box.

- Carry out the same test in all the four ballast prods.
