DD921BK

Downdraft 90cm flip hood

Technical information

Down Draft Trouble Shooting Guide

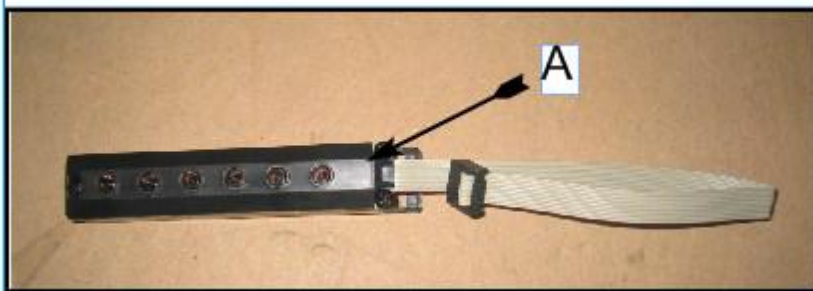
- Remove the upper front panel as shown in previous Chapters.
- The push-button panel that CAPLE supplies as a spare part is equipped with a Ribbon cable and a connector (A)
