DD930BK

Downdraft Induction Hob

Technical information

Trouble shooting

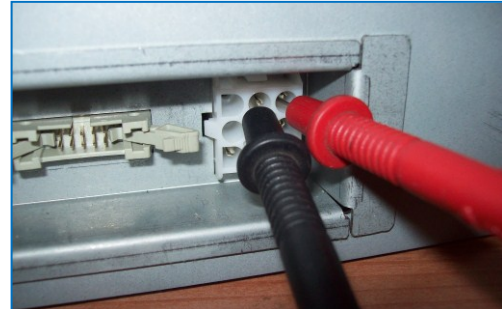
- To check the sensor proper working, you need to place the tester rods at the Yellow and Grey wires of the 9-pole fixed connector . If the sensor works properly the tester should show an open circuit

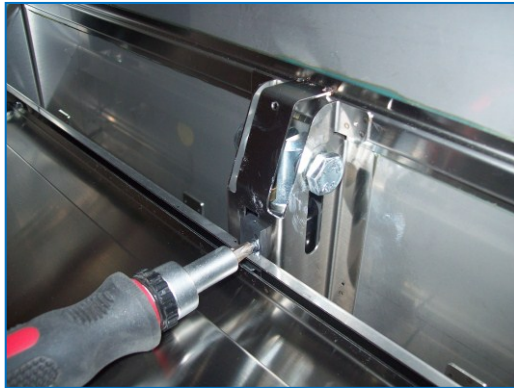
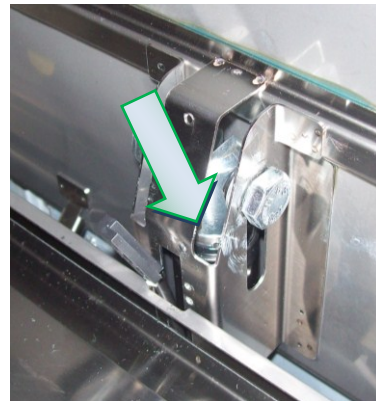
- If the circuit is still closed after having moved the sensor, you need to replace the sensor . Unscrew the two screws, cut all of the sensor cable fixing clamps and remove the sensor by pulling it from the bottom.

(Since the magnet shall be placed in the same position of the damaged one, carefully check the cable, clamps and sensor position before removing the magnet.)

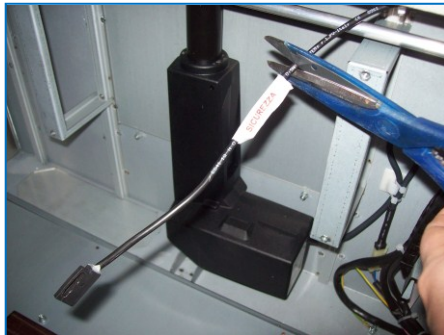
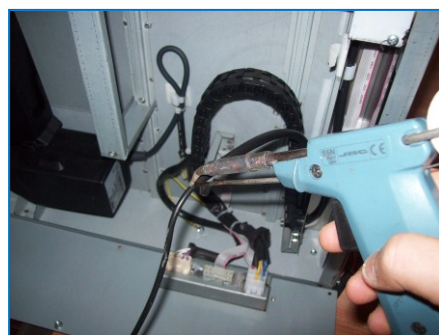
- Then cut the sensor cable and replace it with a new one, welding its wires with a soft-soldering welder.

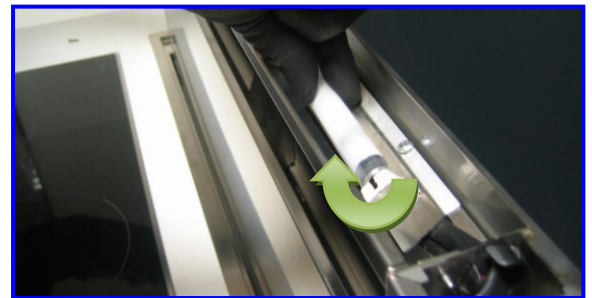
- Remove the neon tube and replace it with a new one.

NARVA
LT 14WT5/865 cool daylight
www.narva.be

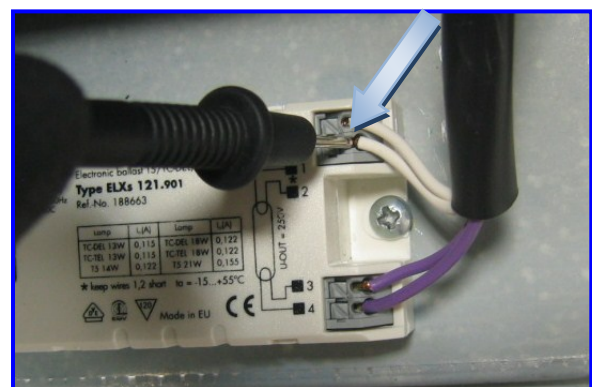
- Carry out an electric continuity test between the neon tube holders and the ballast inside the electrical system box.
- Place a test prod in one of the neon tube holders contacts and check the ballast continuity inside the electric system box.

- Carry out the same test in all the four ballast prods.

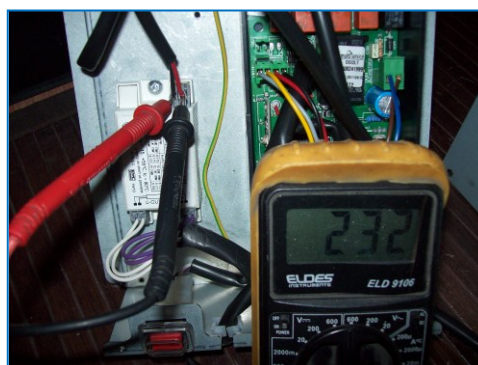
- Place the test prods at the ballast inlet and check if there are 230V.

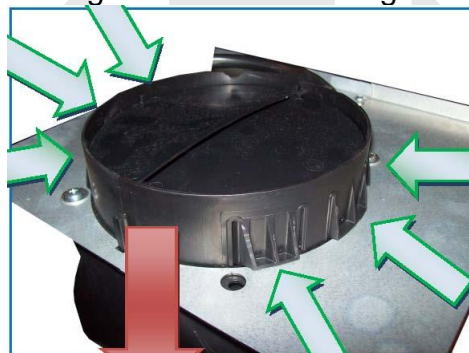
Push the air out-let side tongues of the suctioning unit and pull it downwards.

Replace the suctioning unit with a new one of the same kind (see the spare parts list).

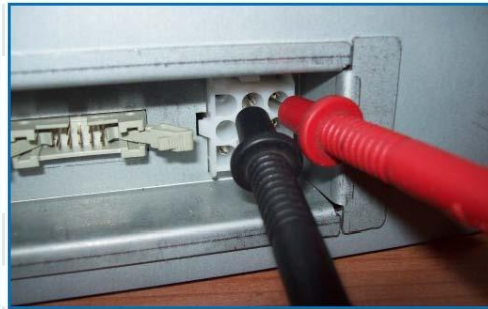
To check the sensor proper working, you need to place the tester rods at the Yellow and Grey wires of the 9-pin fixed connector. If the sensor works properly the tester should show an open circuit

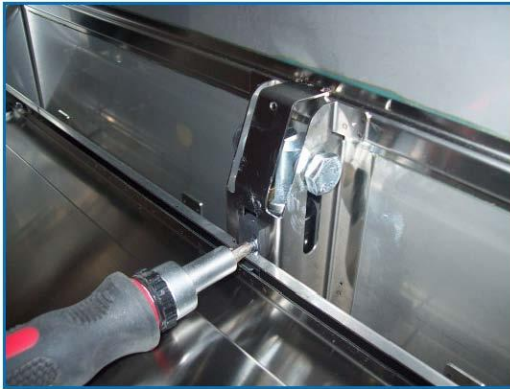
If the circuit is still closed after having moved the sensor, you need to replace the sensor. Unscrew the two screws, cut all of the sensor cable fixing clamps and remove the sensor by pulling it from the bottom

(Since the magnet shall be placed in the same position of the damaged one, carefully check the cable, clamps and sensor position before removing the magnet.)

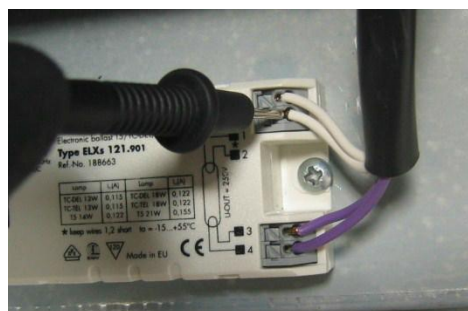
Place a test probe in one of the neon tube holder's contacts and check the ballast continuity inside the electric system box.

Carry out the same test in all the four ballast prods.

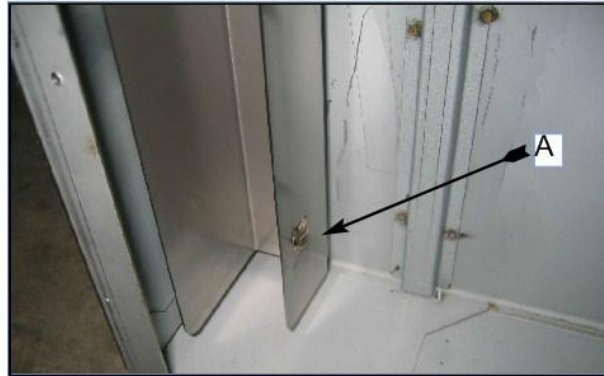
If the sensor is working properly, when the extractable unit reaches 180 mm of height in the multi meter, some seconds of electric continuity must be noticed. If there is no electric continuity, check if the magnet (A) in the extractable unit column is placed properly.
