# WI3115

Caple 30cm Wine Cabinet

**Service Manual**

(One temperature zone control wine cooler)

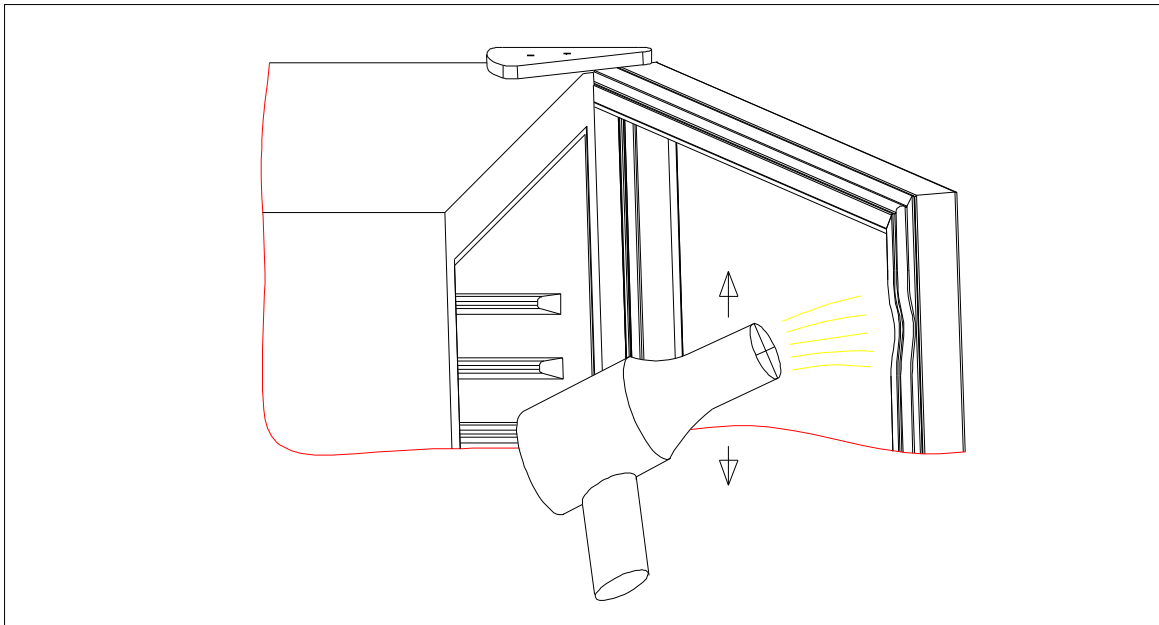
Fig.12

1>. Ensure door is sealed against the frame, if there is slight distortion of the seal, heat the effected area gently with a hair dryer genrly see (fig 12) with smooth strokes of the hair dryer, then when still warm pull the effected area back into its original position, this process may have to be repeated until the seal is completely back to its original condition.

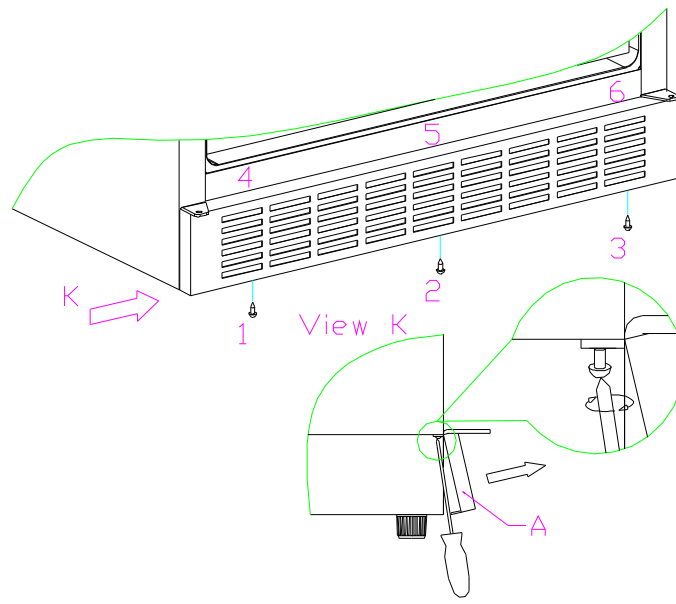
Fig.25

Remove the screw(1,2,3), pull the decorative frame according to the arrowhead that view K show, then remove the screw(4,5,6) from the gap between decorative frame and cabinet, remove the decorative frame. (Fig.25)
