WI3117

Caple Wine Cabinet

Service Manual

(One temperature zone control wine cooler)

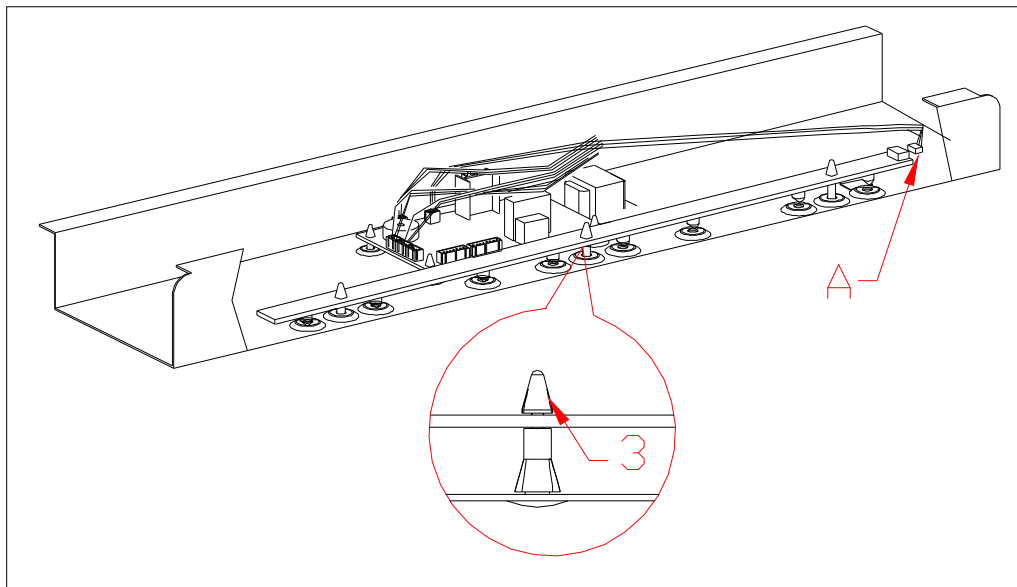
Fig.24

Remove the electrical box, Unplug the LED light connector, press the 4 studs one by one, take the LED light upward, replace it. (Fig.24)
