WI6117

Caple 60cm wine cabinet

Service Manual

(One temperature zone control wine cooler)

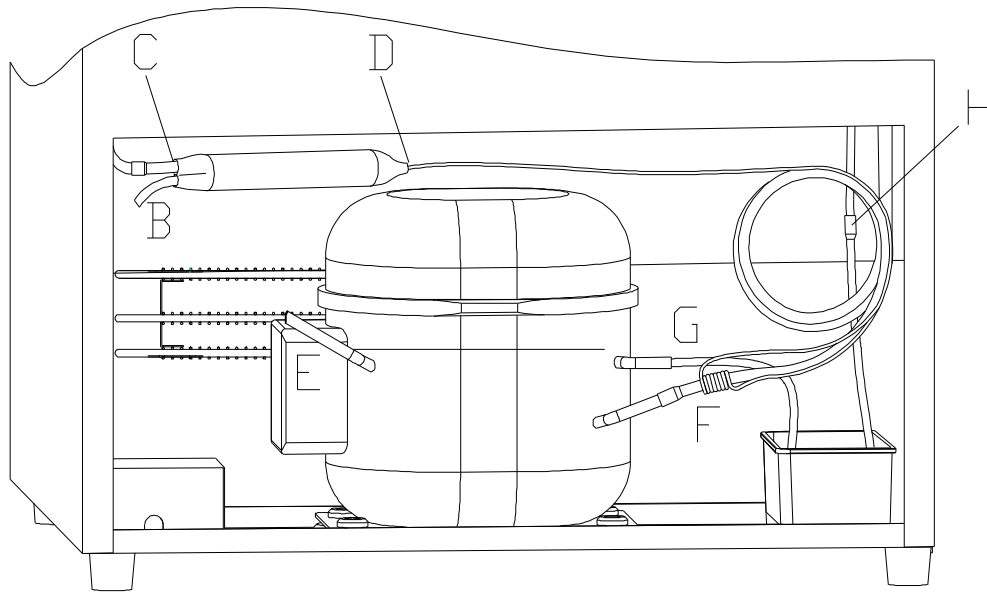
Fig.9.1

- B: Dry filter process pipe soldered joint C: Dry filter soldered joint D: Capillary soldered joint
- E: Process pipe soldered joint F: Suction pipe soldered joint G: Discharge pipe soldered joint
- H: Condenser process pipe soldered joint I: Anti-Dew pipe soldered joint

Outboard condenser

B. Make sure the capillary is working normally, when the drainpipe is conncted again, and infuse 0.8-1MP nitrogen then test the leakage if the cooling system of the soldering point with the soap water. Check from the the soldering point around the compressor(Fig.8 & Fig.9、Fig.9.1), and if everything is ok, remove the air-duct board and chech the soldering point around evaporator(Fig.6 & Fig.7). please see the remove method and the procedure as below. (Fig.1, Fig.2 ,Fig.3, Fig.4 & Fig.5)

- 1>.Heat the soldered joint of the capillary (A of Fig.8 and Fig.9, Fig.9.1), then remove the capillary from the evaporator and smooth the end with an eraser (Caution: Do not allow any particles into capillary unit)
- 2>.Replace the capillary into the evaporator, then solder it back into the correct position (not exceeding 15mm in the evaporator) and pack the joint with anti vibration compound
- 3>. Recharge with refrigerant. See (Page7)

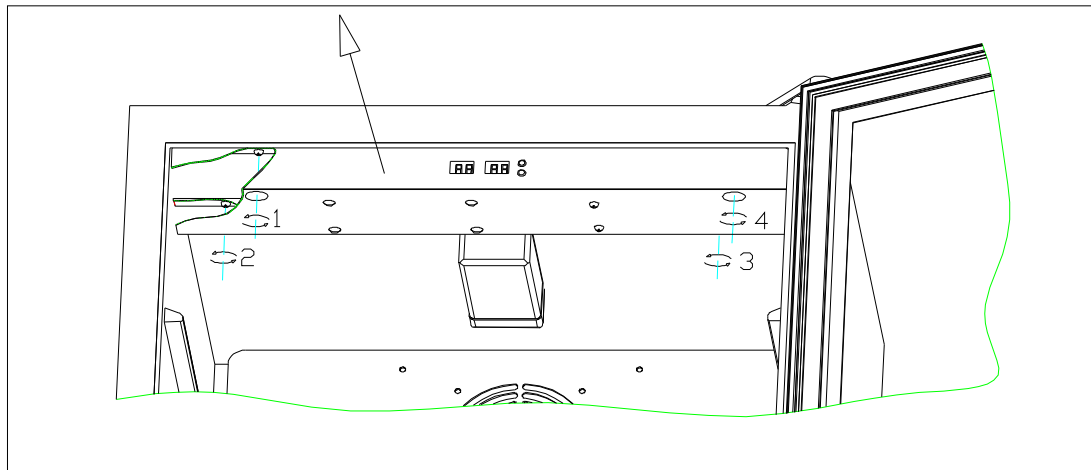
Fig.18

- 1 >. Remove the shelves; see (Fig.1, Fig.2 ,Fig.3, Fig.4)
- 2 >. Remove the two screws at back of electrical box (2,3), then half-remove the two front screws (1,4), then remove the electrical box; see (Fig.18)

1 >. Normally the LED temperature display should the ambient temperature shortly after the unit is plugged in, if not, disassemble the electrical box see (Fig.18 & Fig.19), check if the sensor plug marked “XI” connected properly, if this connection is made correctly and the fault persists replace this sensor,

Replace the electrical display board fault; see (Fig.18& Fig.19)

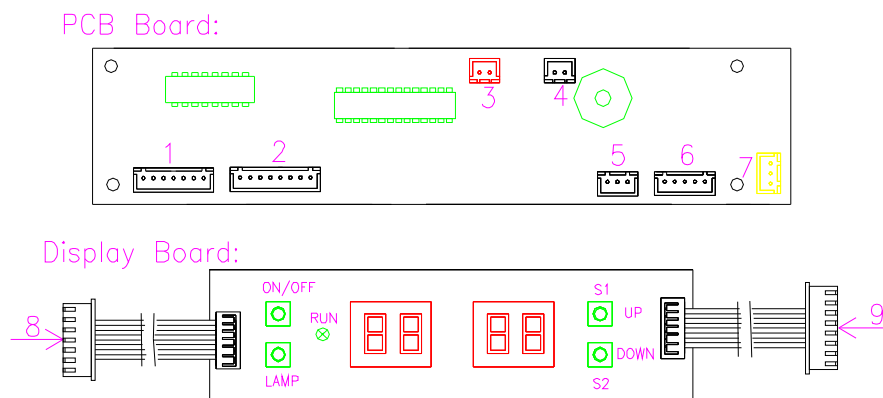
Fig.20

Diagram of the main PCB(Fig.20).

| 1. To display PCB(connect to 8) | 2. To display PCB(connect to 9) |
| 3.To evaporator sensor (Red) | 4.To inner sensor(White) |
| 5.To LED light (White) | 6.To power PCB (White) |
| 7. To outer fan (Yellow) | |
